Cooling

Mondeo III 2.0TD, 2.2TD / X-Type 2.0TD

COTB 0002

Wear to PAS Splined Drive

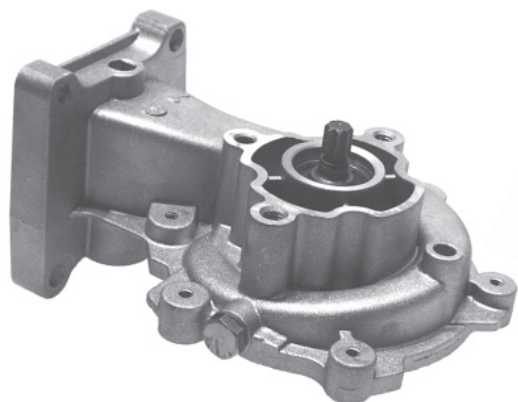
FWP1948
Pump Only

Examination of the condition of the splined drive from the Power Steering Pump **MUST** be made prior to the installation of a new Water Pump. If there is any evidence of wear the Power Steering Pump **MUST** be replaced at the same time as the Water Pump.

Remove all traces of old grease from the pump drive shaft splines then remove and discard the old 'O' ring seal. Fit the new 'O' ring and apply the contents from the grease sachet to the Power Steering Pump drive splines before fitting to the new Water Pump.

The 'O' Ring Seal and Grease sachet can be obtained by ordering First Line part number FWK001 (equivalent to Ford Service Part Ref. 1368570).
