# **febiexakt** High precision quality

**Connecting rod**

VW Sharan (ref. no. 7M3 411 371C) Seat Alhambra (ref. no. 7M3 411 317C) Ford Galaxy (ref. no. 1 361 653)

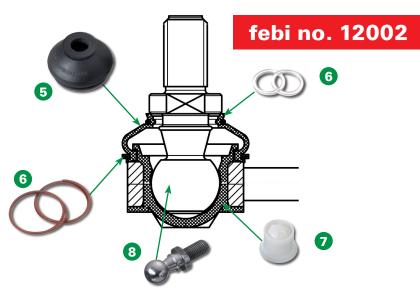
The parts cause noise whilst driving.

Due to its design and location (refer to picture 1) the connecting rod is subject to strong external forces. Both joints are completely exposed to water spraying up from wet roads. A damaged rubber boot (refer to picture 2 and 3), i.e. damaged by road debris, makes it easier for water and dirt to find its way into the joints. Consequently the protective grease will be washed out and the ball pin oxidises. As a result of this, the roughened ball surface increases wear to the plastic ball cup (refer to picture 4), which leads to the joint moving around and causing noise.

#### Rubber bellows (refer to picture 5):

- High performance rubber compound ensures the required flexibility
- Shaped to seal the joint system at each angle
- Proven grease resistance

#### Piston rings (refer to picture 6):

The locking rings are specifically designed for this application, in order to support the sealing characteristics of the rubber boot

- Use of high performance grease for the ideal lubrication of the ball cup (refer to picture 7) and the ball pin
- Corrosion protection for the whole system
