febiEXAKT

Chain tensioner

febi No. 33044

Vauxhall 2.0l turbo and 2.2l petrol engines

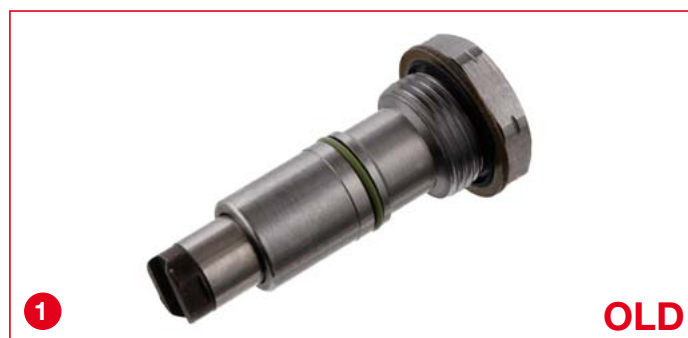
A blocked timing chain tensioner. The original version (repl. no. 0636 549) of the chain tensioner had a green O-ring and a rubber-lined washer (see Fig. 1). The vehicle manufacturer fitted this version in the engines mentioned above. A modified chain tensioner has been used in production since model year 2009.
