febiEXAKT

Belt tensioner

febi no. 26775

ref. no. 611 200 04 70

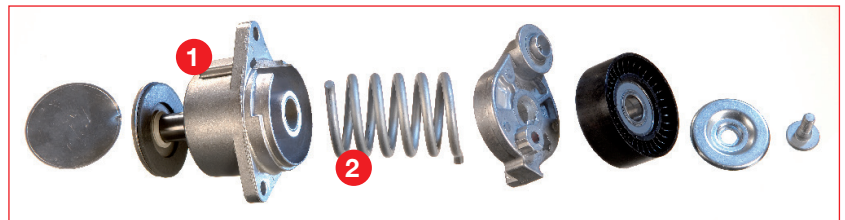
ref. no. 611 200 04 70

The noise is generated because the spring is too long and makes direct contact with the base of the housing (1). Only the spring's torsional characteristics are important for this application (2), (6).

The noise is caused when the spring touches the cast-in hollow pin (3) and the base of the housing (4).
