febiEXAKT

Connecting rod

febi no. 12002

VW Sharan (ref. no. 7M3 411 371C)
Seat Alhambra (ref. no. 7M3 411 317C)
Ford Galaxy (ref. no. 1 361 653)

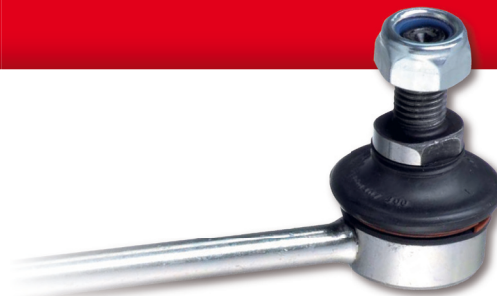
The parts cause noise whilst driving.

Due to its design and location (refer to picture 1) the connecting rod is subject to strong external forces. Both joints are completely exposed to water spraying up from wet roads. A damaged rubber boot (refer to picture 2 and 3), i.e. damaged by road debris, makes it easier for water and dirt to find its way into the joints. Consequently the protective grease will be washed out and the ball pin oxidises. As a result of this, the roughened ball surface increases wear to the plastic ball cup (refer to picture 4), which leads to the joint moving around and causing noise.

Rubber bellows (refer to picture 5):

- High performance rubber compound ensures the required flexibility
- Shaped to seal the joint system at each angle
- Proven grease resistance

Piston rings (refer to picture 6):

- The locking rings are specifically designed for this application, in order to support the sealing characteristics of the rubber boot

The grease:

- Use of high performance grease for the ideal lubrication of the ball cup (refer to picture 7) and the ball pin
- Corrosion protection for the whole system
