# febiEXAKT

## Triangular control arm

Premature failure of the triangular control arms central bearing.

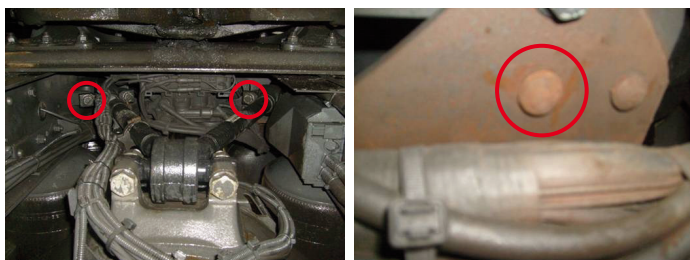
Both bearing mounting brackets which link the triangular control arm to the chassis are joined to the chassis via mounting plates.

The mounting plates are attached to the frame with rivets. The components referred to are subject to significant stress during loading and unloading and this applies even more if the truck is overloaded or road conditions are poor.

These loads can lead to the rivets working free. The bearing mounting bracket which is joined directly to the triangular control arm may exhibit play due to the lost rivets. Even a minimum amount of play is enough to transfer additional forces to the central bearing. The central bearing, however, cannot withstand these unforeseen loads and fails as a result of the additional stress.

Check the mounting plates before fitting a new triangular control arm. If a rivet has been lost, it can be replaced with a screw. This screw is sufficient to minimise the play and the central bearing will again be subjected only to the forces for which it was intended. febi bilstein recommends the use of febi 26709/26710 threadlocker for maximum hold. The liquid plastic which cures in the absence of air prevents re-lease or loosening of the threaded joint between screw and frame even under the most severe operating conditions.
