ROVER GROUP

200 / 400, Mini, Metro, Maestro, Montego

AUTO ADJUST CLUTCH CABLE ISSUES

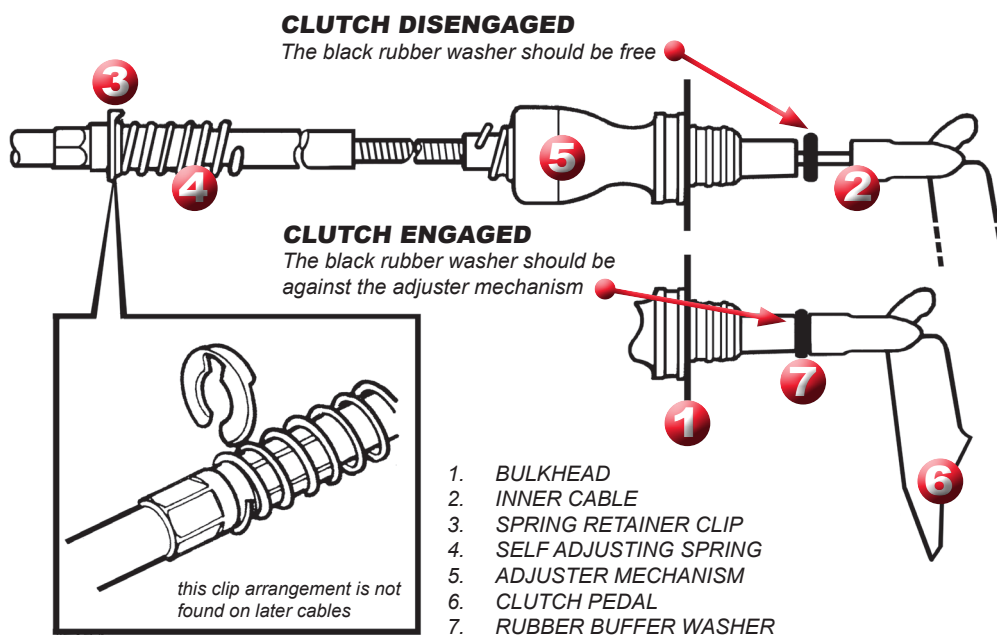
Clutch engagement whilst pedal is still very close to floor and also a common cause of slip/premature wear to the driven plate facings. This can be due to failing action of the auto-adjust mechanism.

Make sure that the auto adjust mechanism is correctly located in the bulkhead and that the ends of the cable have been located in the gearbox lever and to the top of the clutch pedal. The spring C clip should be fitted if required as per the illustration below. Check that when the pedal is at rest, that the rubber buffer washer can press against adjuster mechanism tube whilst still having some upward movement left before striking the pedal return stop. If not it may be due to too much slack in the cable, you may have to help it initially by holding the adjuster mechanism body with one hand and with the other hold around the self adjust spring moving them apart. (This will take out any slack.)
