Service Information XZS110

Noise Occurrence on GDB1363 and GDB1431

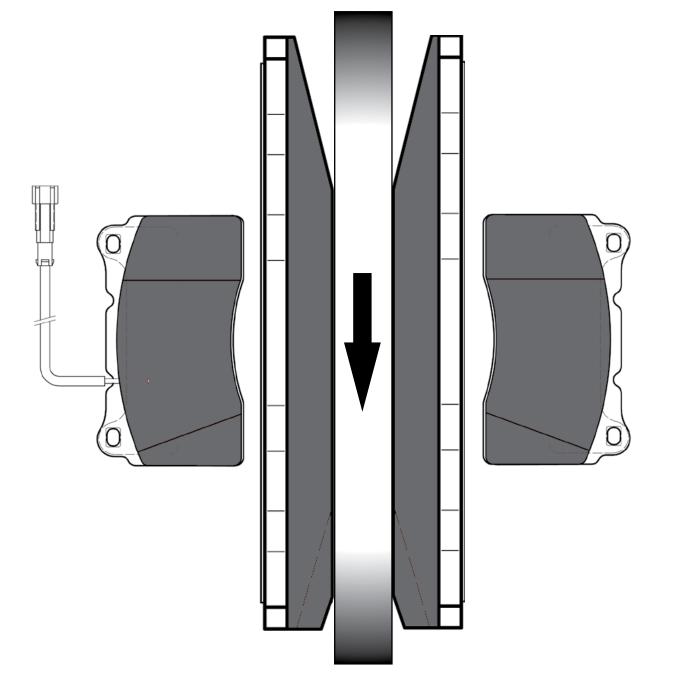
GDB1363 and GDB 1431 are chamfered on one side. The reason for this is to minimise noise. The arrow indicates the disk forward rotation. If the Brake Pads are not fitted as shown above, noise will occur. To ensure the correct fitment in future TRW will print indicator arrows on the back plate.
