VAG 1.9 D / Synchronous Drive / Installation Info.

GATES REFERENCE:	5543XS & Kits, 5559XS & Kits	
MAKE:	AUDI / SEAT / SKODA / VOLKSWAGEN	
MODEL:	A3, Cordoba, Ibiza, Inca, Leon, Toledo, Octavia, Bora, Caddy, Golf, New Beetle, Polo	
MOTOR:	1.9SDI, 1.9TDI	
MOTOR CODE:	AGP, AGR, AHF, ALH, AQM, ASV, ASY, AYQ

Introduction.

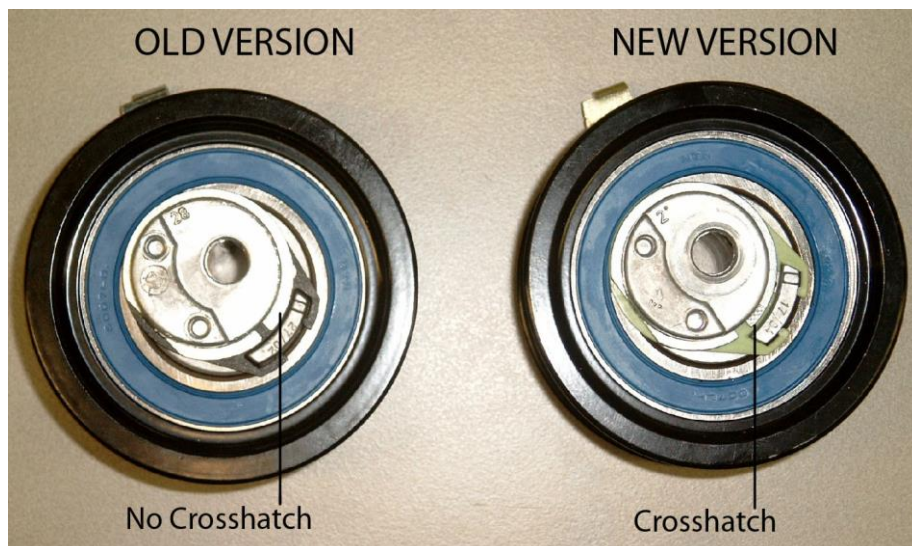
In Fig. 1 you can see that only the new version has a crosshatch belt wear indicator (see also Fig. 4). This section indicates when the timing belt is worn out and when it needs replacement.

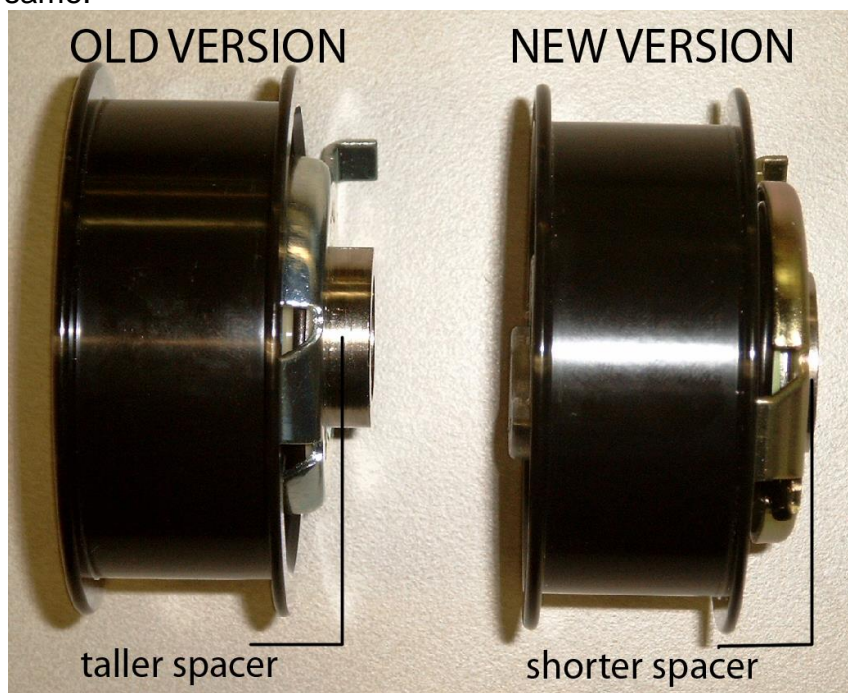
In Fig. 2 you can see that the new tensioner also has a shorter spacer. However, the distance between the engine block and the pulley remains the same.

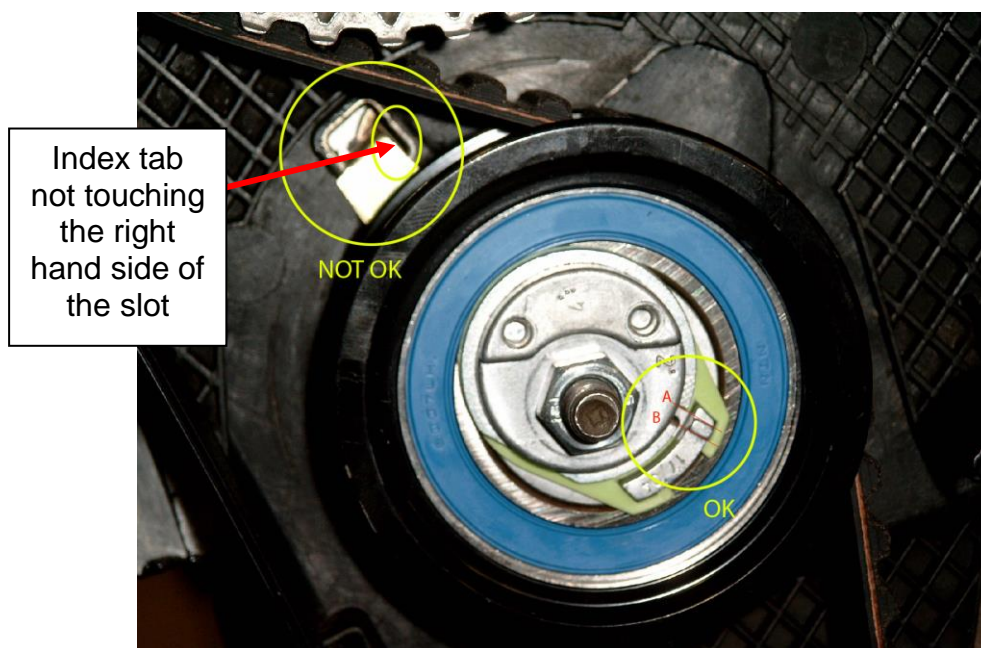
Fig. 5 shows one of the common errors. Pointer is perfectly positioned between lines A and B but the index tab is not OK. The index tab is in the slot but is not pushing against the right hand side of the slot. The reason for this is that the tensioner was moved anti-clockwise during the tensioning process.

If the pointer is not well positioned, the mechanic should restart the tension-setting procedure completely.

When you are in the tension-setting, never turn the tensioner anti-clockwise!

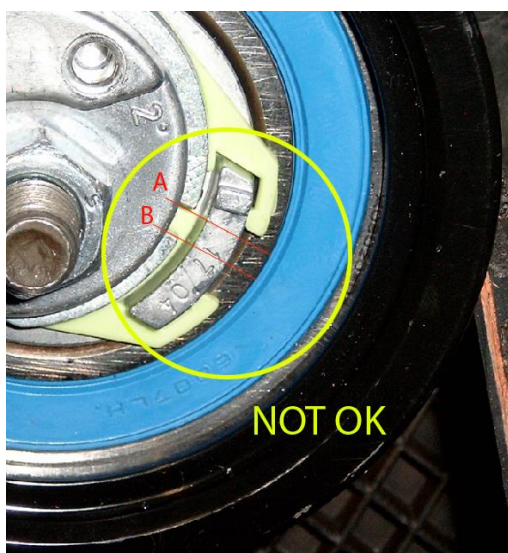
Fig. 6

A second possible error can be seen in Fig. 6. You can see that the pointer has not passed line A and is in front of the crosshatch. This means that the belt will have a too low tension.

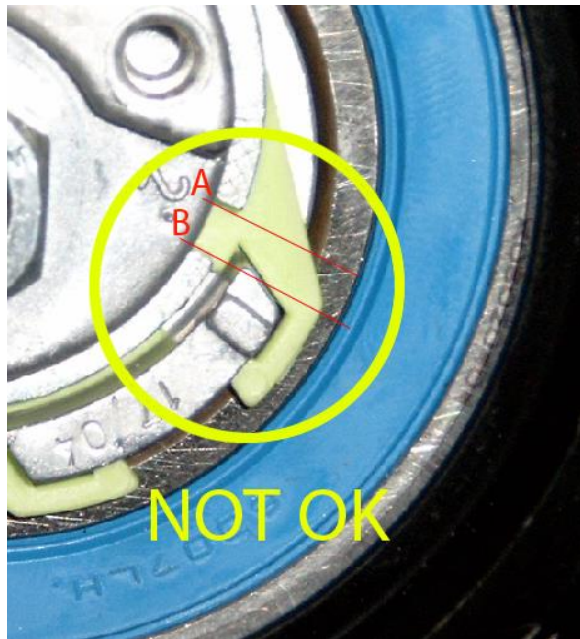
Fig. 7

A third installation error is shown in Fig. 7. The pointer has passed line B, this means that the belt will be tensioned too much.

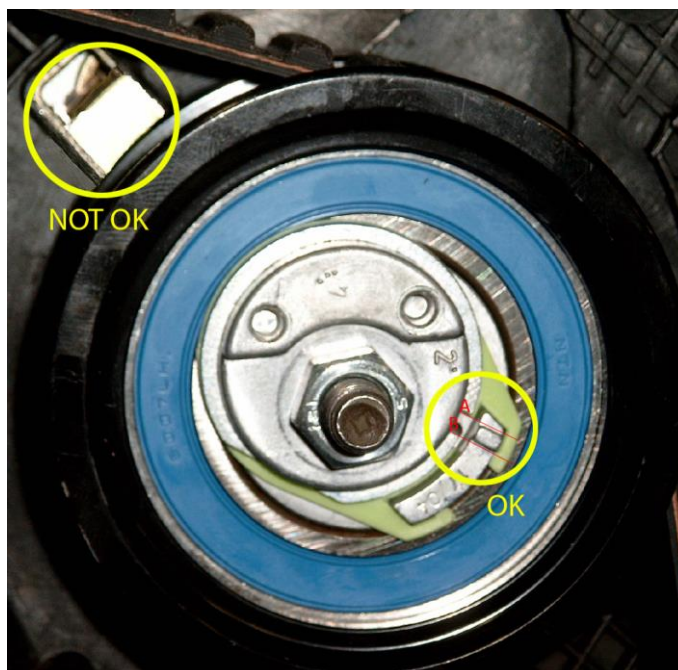
In Fig. 8 you can see a fourth error where the index tab is not locked in the slot although the pointer is perfectly positioned between lines A and B. This way the belt will lose its tension once in operation.

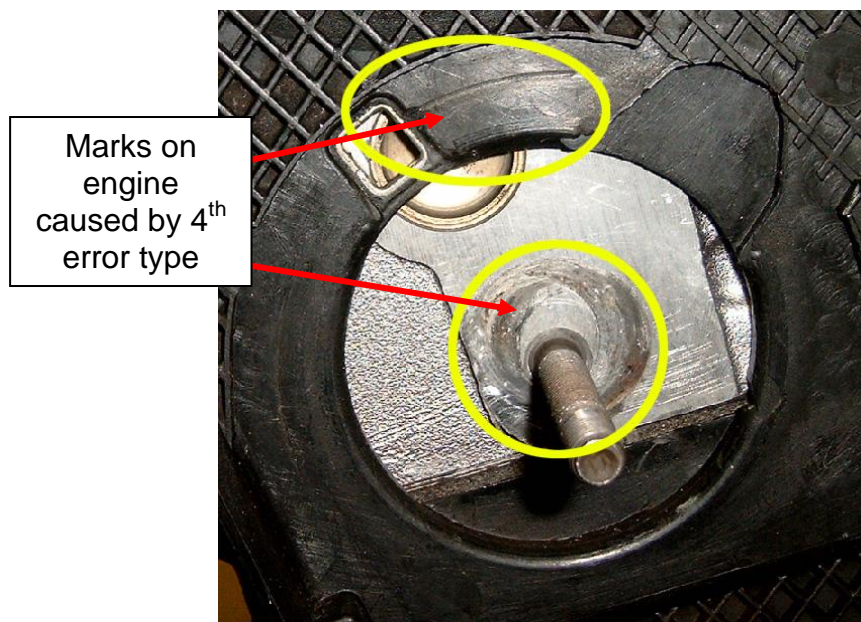
Fig. 9

You can see the marks on the engine caused by this type of wrong fitment in Fig. 9. In this case you will also see that the index tab on the tensioner is slightly bent over.

When the vehicle is released with a wrong positioned tensioner, severe engine damage will happen sooner or later.

We can't stress enough how important it is to follow all the steps in the process of installing this tensioner without skipping one of them. It is better to lose 5 minutes at the installation than to lose an entire engine in the end.
