NUMBER 013

Renault 1.5 DCI / Accessory drive / Installation Info.

GATES REFERENCE: | Accessory drive belt

MOTOR: 1.5 DCI

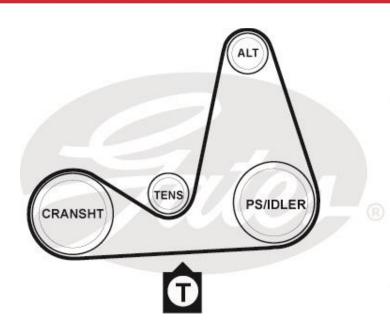
Fig. 1

8. Tension the belt: the belt has to be tensioned (with tool Mot.1638, OE ref. 0000163800) to a higher tension than with the original drive set-up. Measure the tension in the bottom span, between the crankshaft and power steering pump (or idler for cars without power steering) (Fig.1).

- 9. When measuring the belt tension with the STT-1, key in "8", "180" (virtual span of 180 mm). When measuring with the Krikit[®], tension has to be 70 Kg.
- 10. Now tighten both bolts (36 Nm).
- 11. Rotate the engine 2 revolutions clockwise.
- 12. Check the tension and adjust if needed.
- 13. Re-install all removed parts.
