### NUMBER 026

### 17/11/2008

SOFIM 2.4, 2.5, 2.8 Diesel / Synchronous Drive / Installation Info.

**GATES REFERENCE:** 5039, 5113, 5334XS, 5335XS, 5495XS &

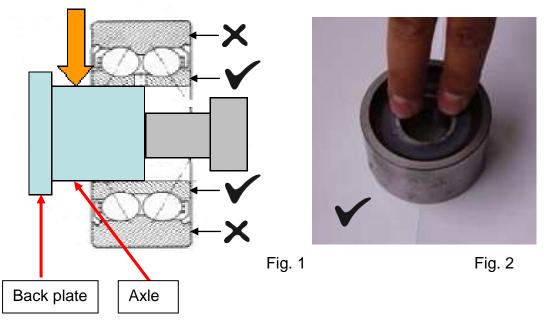
- Always remove rust or remaining grease from the axle/back plate before assembly (orange arrow). If you fail to do this, you will push all the dirt to the bottom of the back plate creating a build-up of debris, which will damage the bearing due to misalignment or create an incorrect tightening torque.
- Always install the bearing by pushing on the centre part of the bearing (▼)
- Never force the idler over the axle by pushing on the outside of the bearing (**X**). (Fig. 1 and Fig. 2)

This would lead to misalignment of the bearing and cause an idler brakedown. It also could lead to the seal coming loose, causing loss of grease and dirt penetration into the bearing.

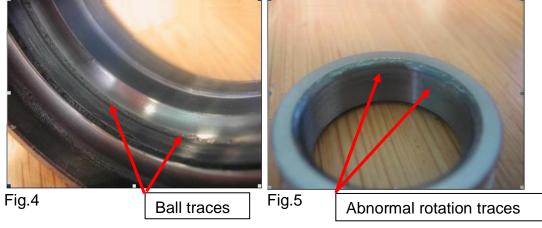
Fig. 4: The bearing balls rolling outside their track due to misalignment and incorrect torque setting.

Fig. 5: Abnormal rotation of the interior rings through incorrect tightening.
