VAG 1.9, 2.0 TDI / Accessory drive / Installation Info.

GATES REFERENCE:	T38306 & related kits.

MAKE:	AUDI / SKODA / VOLKSWAGEN.	
MODEL:	A4, A6, Bora, Golf, Passat, Superb.	
MOTOR CODE:	AJM, ATD, ATJ, AUJ, AVB, AVF, AXR, AWX, BGW, BPZ, BSS, BSV.

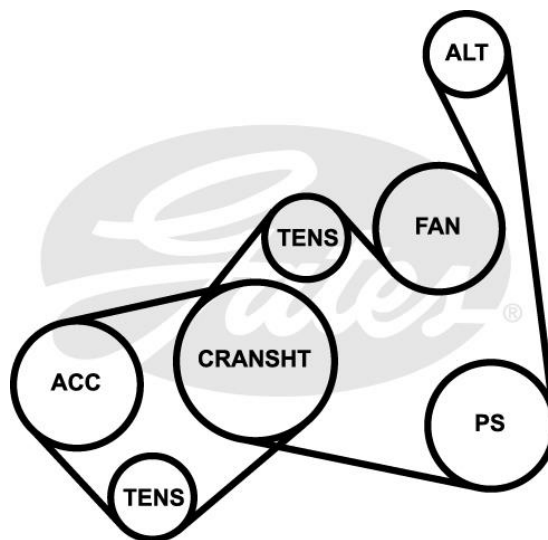
Fig. 1

The layout of the drive is shown as the alternator drive in Fig. 1. As this is a demanding drive, the alternator pulley is of the overrunning (free wheeling) type and the crankshaft is equipped with a Torsional Vibration Damper (TVD).

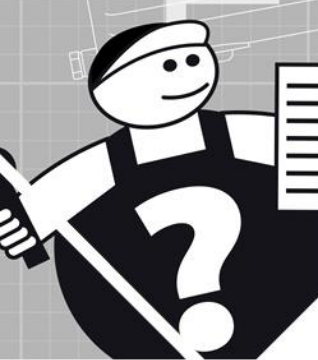
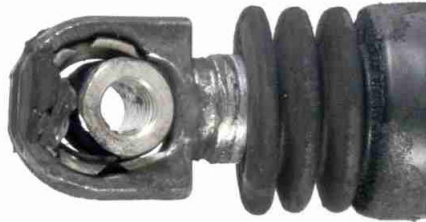
Fig. 2

An Overrunning Alternator Pulley (OAP) which is not working properly will create even more belt vibrations and noise. This can lead to excessive wear of the fixing hole at the top of the hydraulic actuator. (Fig. 2)

You can check if the OAP is working properly:

A) with the belt installed: one has to be able to turn the inside fan blades of the alternator clockwise.

B) with the belt removed: turn the pulley hard by hand in the clockwise direction. Immediately turn the pulley in the other direction. The inside fan blades of the alternator have to keep running in the clockwise direction. If they do not (and stop directly), this means the pulley is out of order.

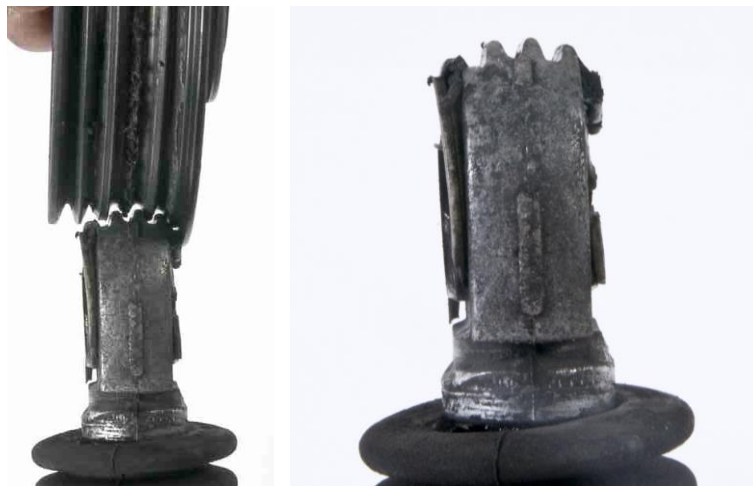
Fig. 3

This play can become enormous, leading to the tensioner body touching the tensioner pulley, causing a lot of noise. In its extreme form the tensioner body will even get grooved, because the pulley is “grinding” it. (Fig. 3)

It is therefore essential that the complete drive is checked regularly. We recommend replacing the belt, tensioner, OAP and TVD at the same time.

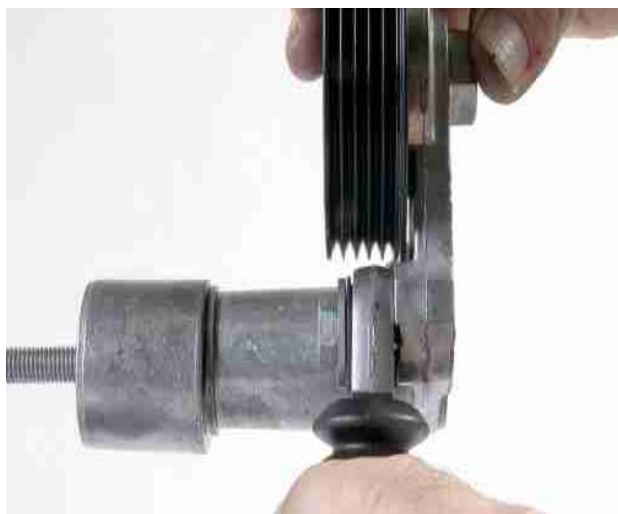
Fig. 4

In new condition, the free space between pulley and tensioner is 5 mm. (Fig. 4)

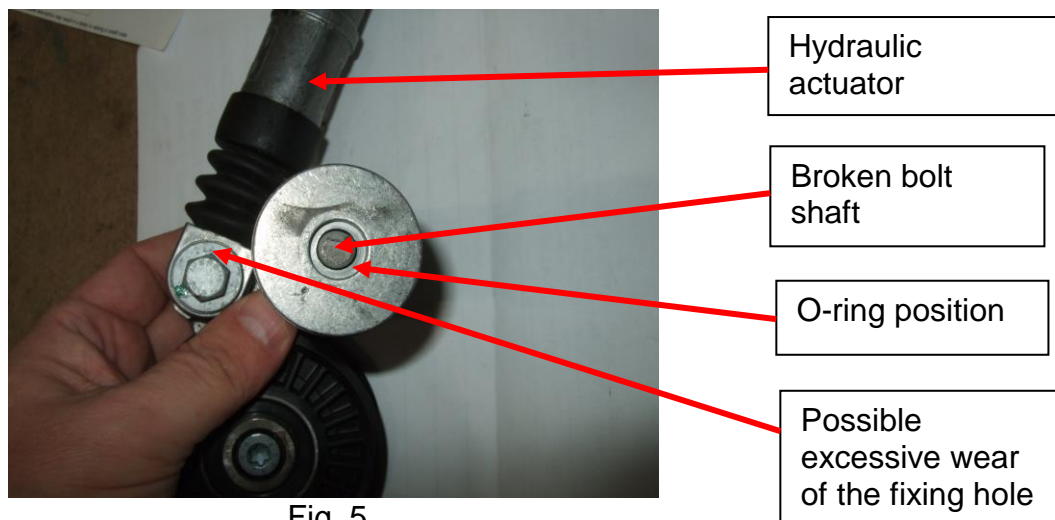
Fig. 5

Also the installation torque of the tensioner mounting bolts is critical. Failure to apply the correct torque will usually lead to the central mounting bolt shearing (Fig. 5).

If the mounting bolts are too tight it will distort the mounting bushing, preventing the hydraulic actuator to pivot on the mounting bolt. All forces are therefore transmitted to the central mounting bolt, which eventually shears.

Bolts on this tensioner should be torqued to 25Nm. In order not to influence the torque of the central bolt, make sure that the o-ring is sitting correctly in its foreseen location. (Fig. 6)

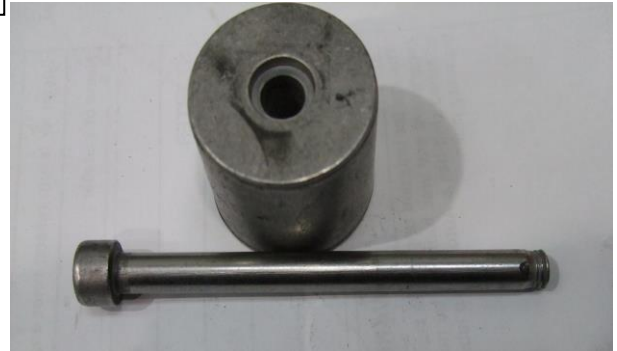
Fig. 7

A too low torque on the central bolt will lead to the load/vibrations being absorbed by the bolt shaft, also resulting in a bolt rupture (Fig. 7).

Also make sure the hole in the alternator bracket is free of rust, dirt and grease, as this again could influence the bolt torque.
