Renault 1.4 & 1.6 16V / Synchronous Drive / Installation Info.

<b>GATES REFERENCE:</b>	<b>5501XS, 5671XS &amp; related kits.</b>

<b>MAKE:</b>	DACIA / LADA / NISSAN / RENAULT.	
<b>MODEL:</b>	Clio, Duster, Fluence, Kangoo, Kubistar, Laguna, Largus, Logan, Megane, Modus, Sandero, Scenic, Symbol, Thalia, Twingo, Wind	
<b>MOTOR:</b> <b>MOTOR CODE:</b>	Petrol 1.4 16V, 1.6 16V. K4J/K4M.

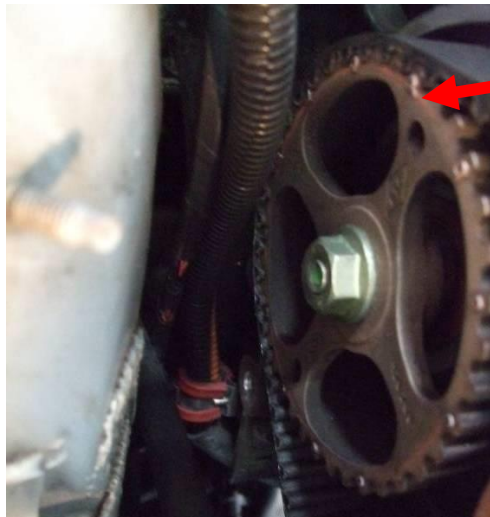
Fig. 1

In this drive, excessive play from the water pump bearing often occurs, this leads to belt tracking forward and forces the camshaft pulley flanges to detach and possibly enter the drive system. The result is belt failure. Also earlier mechanical damage to the flanges can lead to this (Fig.1). The camshaft pulley design has changed on these engines (but the OE ref. remained the same), in order to prevent this failure mode.

Flange detached

We always recommend servicing with a complete water pump kit. While changing the water pump, make sure the correct bolts/washers are used and torqued correctly.

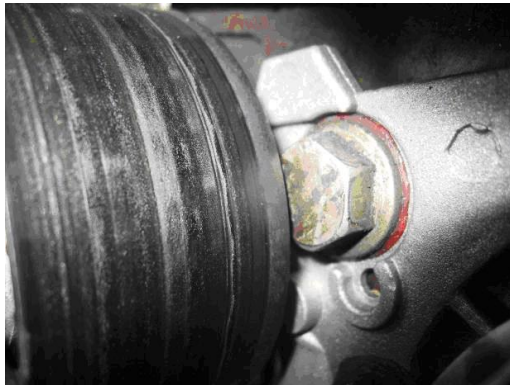
Fig.2

Fig. 2 shows the little space between water pump bolt and tensioner pulley.

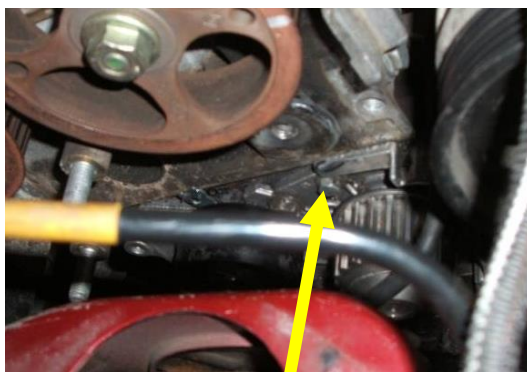
Fig. 4

While installing the new idler pulley, ensure that the spacer (sitting between the old pulley and the engine block) is re-fitted between the new pulley and the engine block. If not, the idler pulley can touch the water pump, causing idler and belt failure (Fig. 4 and 5).

Rubbing mark

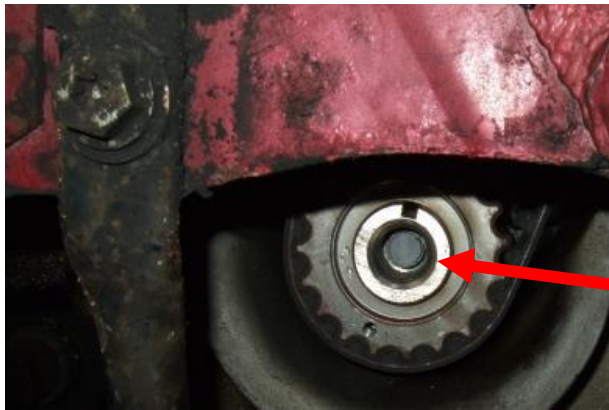
Fig. 6

The crankshaft bolt can't be re-used. (OE ref. is 8200557644. This is supplied with the kit). The correct torque setting of this bolt is very important and varies per engine code or model. Incorrect torque causes bolt shear. (Fig. 6)

Bolt sheared

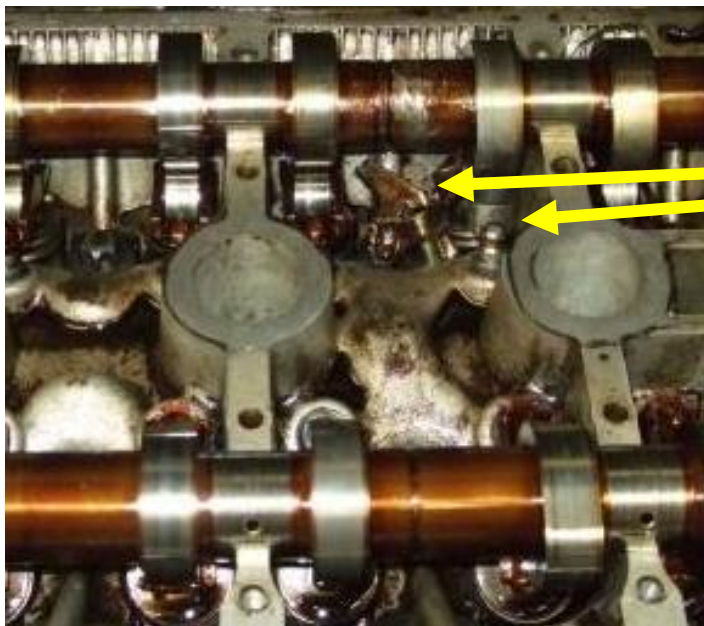
Fig. 7

In the event of an engine repair, after piston to valve contact, a close inspection of the camshaft rockers is essential. It is possible that rockers sustained damage. If so, the rockers must be replaced. Neglecting their replacement causes seizing of the camshaft. (Fig. 7)

Rocker broken
