VAG 1.4 & 1.6 16V / Synchronous Drive / Installation Info.

GATES REFERENCE:	5565XS & related kits.	
MAKE:	AUDI, SEAT, SKODA, VOLKSWAGEN.	
MODEL:	Various.	
MOTOR CODE:	1.4 16V, 1.6 16V.

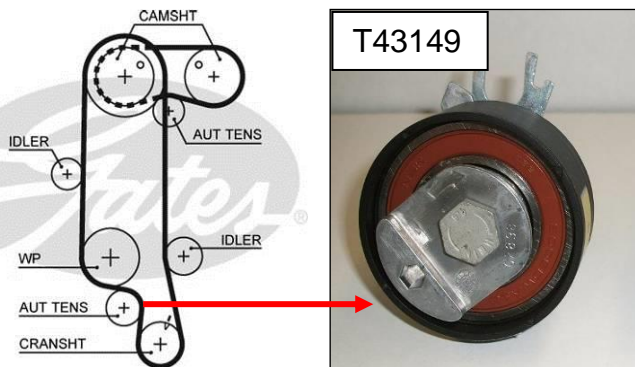
Fig. 1 shows the 2 different versions of the automatic tensioner (for the main drive) to be found in our kits. They are interchangeable.

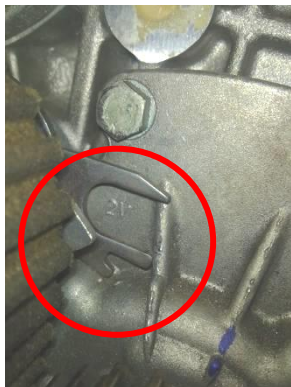
Fig. 2

Any incorrect position of the locating lug (Fig. 2, 3 and 4) will lead to an incorrect belt tension or to the fact the belt cannot be tensioned correctly.

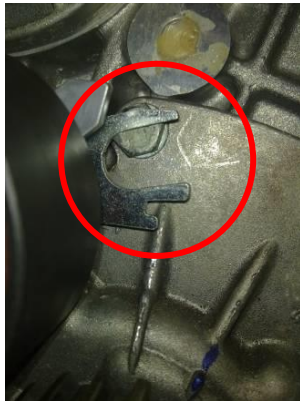
Fig. 5

If the tensioner is torqued up while the locating lug is sitting on the bolt's head (Fig. 5 and 6), this will lead to a deformation of the lug (Fig. 7), an incorrect torque of the tensioner bolt and possible tensioner misalignment.

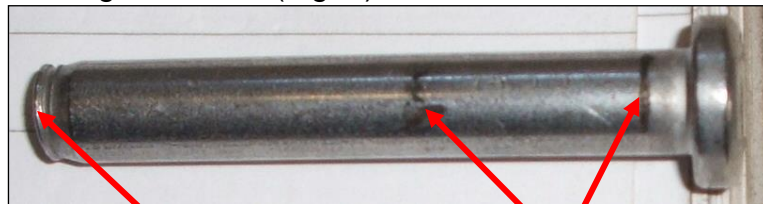
Fig. 8

The incorrect (too low) torque can lead to the bolt coming undone (due to vibrations) resulting in the load being transferred to the mounting bolt shank, causing it to shear (Fig. 8).

Bolt sheared off

Tensioner contact marks

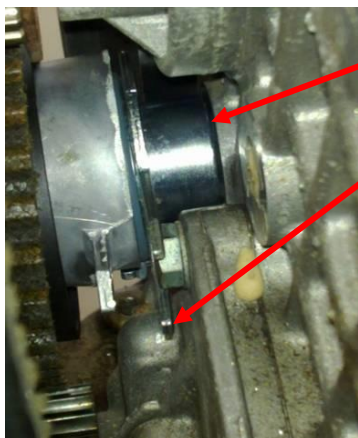
Fig. 9

Though the locating lug is correctly placed, possible incorrect sitting of the tensioner against the engine block after the tensioner bolt is torqued, leaving a gap between the tensioner and the engine block (Fig. 9).

Gap
Not far enough over bolt head
No gap
Good position

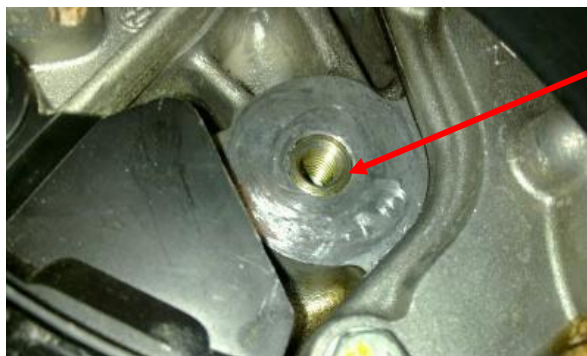
Fig. 11

- deformation of the tensioner leading to overheating of the bearing
- damage of the thread in the alloy engine block, leading to the need of a thread repair (Fig. 11)
- bolt rupture

Repaired thread

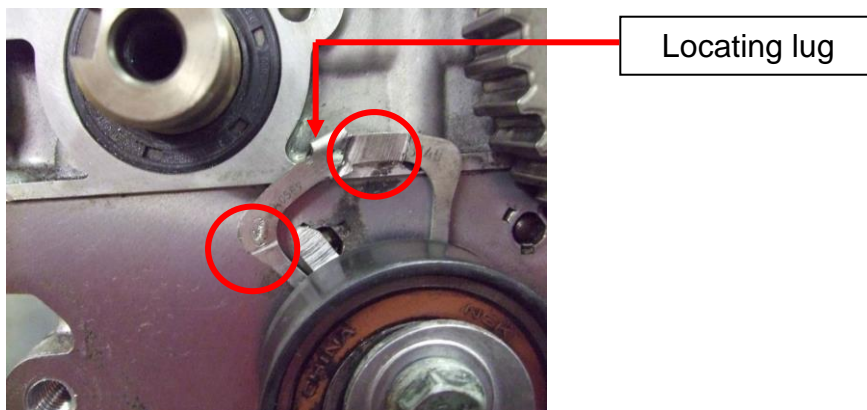
Fig. 18

In one case the tensioner was mounted upside down, with the locating lug trapped behind a part of the cylinder head at 11 o' clock (Fig. 18). When bolting on the tensioner, the back plate deformed, because there was no hole for the lug to fit in.

As a result, the left hand side cam sprocket and the timing belt were touching the back plate, and the belt edge was 'eaten' away until the belt broke. The marks on the tensioner back plate (Fig. 18) and the debris on the inside of the drive cover (Fig. 19) were the clear witnesses of this destruction process.

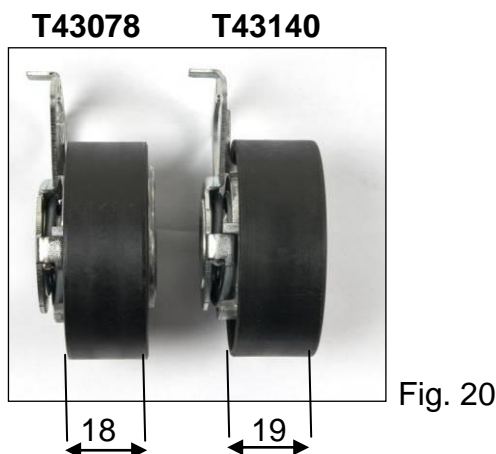
Fig. 20

The pulley width of the tensioner T43078 is 18 mm, for the T43140 the width is 19 mm (Fig. 20).

These tensioners are NOT interchangeable.

Check the online catalogue for the correct parts per application.
