VAG 1.9 D / Accessory Drive / Tensioner info.

GATES REFERENCE:	T38192 & Kits.

MAKE:	AUDI / SEAT / SKODA / VOLKSWAGEN.	
MODEL:	A3, Bora, Caddy, Cordoba, Golf, Ibiza, Inca, Leon, New Beetle, Octavia, Polo, Toledo.	
MOTOR:	1.9 TDI 8V, 1.9 SDI 8V.	
MOTOR CODE:	1Y, 1Z, AEY, AFN, AGR, AHF, AHU, ALE, ALH, ASV, AYQ.

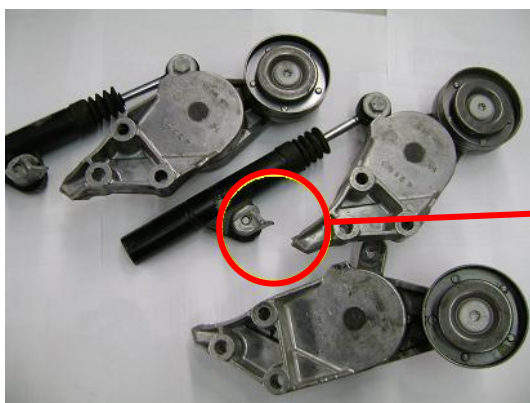
Fig. 1

In most cases where the tensioner seemed to be failing, or even broke down the malfunction of the OAP was proven. The OAP not working properly leads to abnormal belt vibrations, causing the tensioner bracket to be affected by material fatigue; leading to rupture (Fig. 1 and Fig. 2).

The bracket will always shear off at the same point (just above the connection of the bracket with the hydraulic damper).

The broken tensioner bracket is the result of excessive vibrations, not the cause!

The most common root causes for this failure are:

- Worn Overrunning Alternator Pulley
- Solid pulley installed instead of an OE prescribed OAP
- Using an OAD (Overrunning Alternator Decoupler) instead of an OWC (One Way Clutch)

- With the engine running at idle: look for abnormal tensioner movement. If present, the OAP/TVD might need replacement.
- With the engine running at high revolutions, switch it off and listen for abnormal alternator rotor noise. If present, the OAP might have a worn bearing.

- The OAP is a wear item, which has to be checked regularly for proper functioning.
- Replace the alternator pulley only with the prescribed Gates part.
- Follow OE recommended installation procedure.
- Replace all service parts in the drive, use the complete kit.

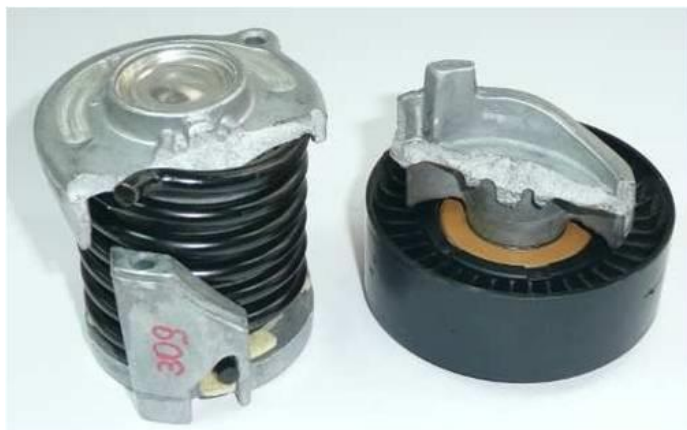
Fig. 3

In all these cases where the OAP did not perform as it should, the hydraulic tensioner element had to cope with abnormal vibrations in the drive; leading to earlier prescribed bracket material fatigue. (Fig. 3)
