Technical Bulletin

Hyundai, Mitsubishi Various Models - Caution Fitting Timing Belt

Applicable References: ADC47514, ADG07607 **Applications:** Hyundai, Mitsubishi Various Models

Date Issued: 07/2002

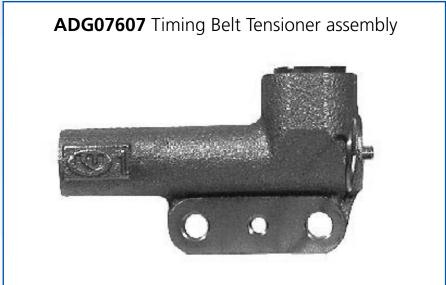
We have experienced several claims for 'timing belt failure' on the above model. Thorough investigation has identified the cause as insufficient timing belt operating tension, resulting from incorrect fitment or damage to the viscous tensioner.

Once fitted, check that the viscous tensioner protrusion is correct (3.8 - 4.8mm). LEAVE FOR AT LEAST 15 MINUTES THEN RE-CHECK THE PROTRUSION. If the protrusion has decreased, replace the tensioner.

Compress the viscous tensioner SLOWLY, otherwise the hydraulic valves inside the unit will become distorted and cause the tensioner to 'over relax' after fitment. Take two or three minutes (using a workshop vice with protected jaws) to compress the tensioner.

Blue Print recommend that the tensioner is replaced as a matter of course. If you have any doubt about the condition of the original viscous tensioner, it should also be replaced.
