Potential problems with Concentric Slave Cylinders (CSC)

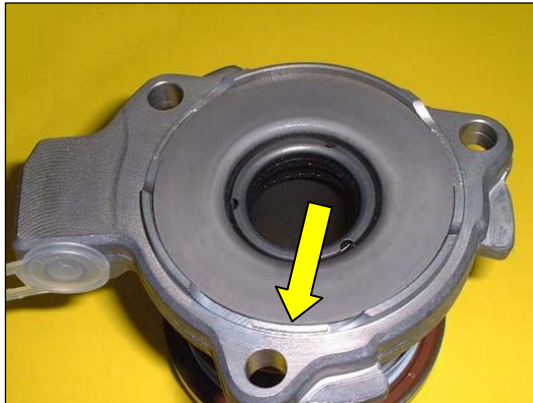
Most of the CSC failures that occur take place during or immediately after fitting or bleeding. Outlined below are the most common causes of failures found with CSC's returned to us recently. Leaking immediately after fitment can be caused by several reasons the most common being;

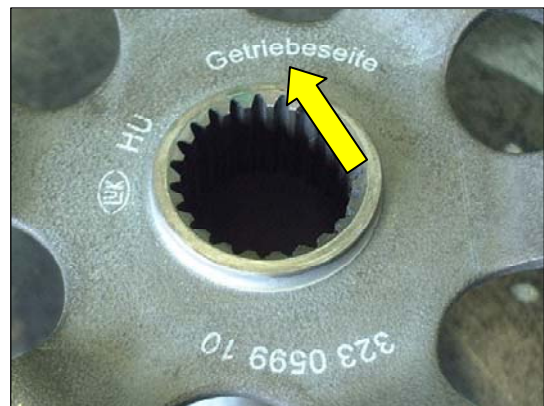
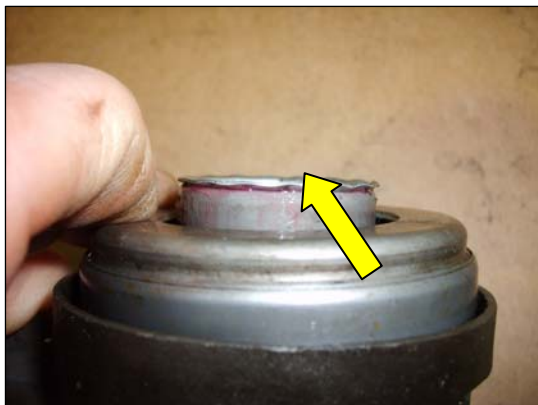
On many applications the splined hub boss protrudes further on the flywheel side than the gearbox side. If the driven plate is fitted facing the wrong way the hub can contact the guide tube causing severe damage to the CSC. Driven plates manufactured by LuK Aftermarket will be marked up with either F/W (Flywheel side) or Getriebe seite (Gearbox side) as shown on the right.
