SERVICE INFO

Important information on avoiding clutch pedal vibrations

Vehicle manufacturer: Audi, Seat, Skoda, VW

Engine: 1.9 TDI

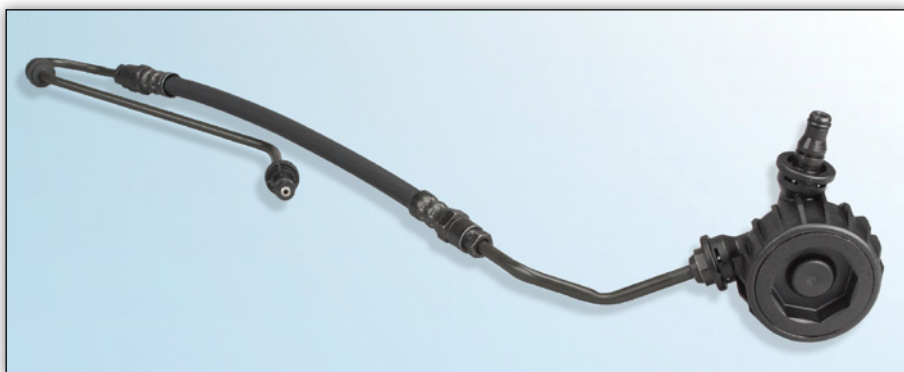
Image 1: Hydraulic line with frequency modulator (anti-vibration unit)

From model year 2003, the vehicles listed above may experience vibrations on the clutch pedal when actuated.

In the event of a complaint, the cause can be attributed to the absence of or a faulty frequency modulator (anti-vibration unit), or to the fact that the electronic control unit software is not up to date.

The vibrations are generated as a result of axial torque deviations in the crankshaft, which are transferred to the pedal via the clutch hydraulics.

The frequency modulator suppresses pulsations in the system's hydraulic fluid, thereby preventing vibrations on the clutch pedal.

- Is the electronic control unit software up to date?
- Is a frequency modulator fitted?

If necessary, the hydraulic line with frequency modulator should be replaced and subsequently refitted. The corresponding replacement parts are available from the vehicle manufacturer.
