Rover "K" Series - Cylinder Head Gasket

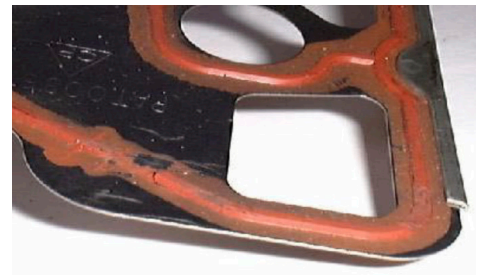
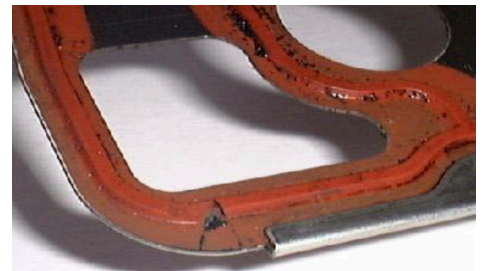
- Cuts/tears in SAC track (silicon bead) on the cylinder head side, often towards the front left and right hand corners of the gasket

- Careless opening of gasket packaging.
- Misalignment of the cylinder head with dowels whilst re-fitting the head, with engine still in the vehicle.

- Do not use sharp blade to open gasket packaging
- Assemble gasket carefully onto engine. Enlist the help of a colleague when lowering the head onto the location dowels.
Note: It is often easier to re-fit the head with all manifolds removed.

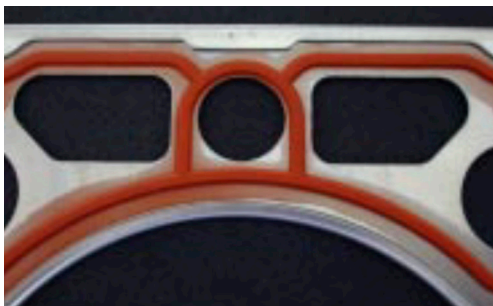
Original

- The "K" series engine is also known for problems caused by oil seepage around number one bore eyelet and into the coolant gallery. This condition results from damage (or omission), during gasket replacement, of the original plastic dowel.
- To eradicate this problem the silicon bead has been modified (see photograph) and the plastic dowel replaced with a steel dowel (Rover - part number LYU100010).
