Issue No. 01
Date 21/11/06
Author RCB

Charging system Isuzu / Opel / Vauxhall.

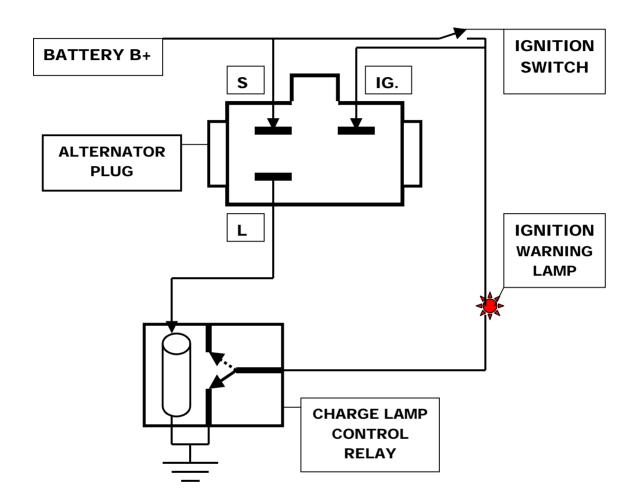
The charging system on most Isuzu, Opel and Vauxhall applications fitted with these alternators have a charge relay fitted in the circuit. One of the functions of the relay is to control the charge warning lamp. When the original alternator fails, it is possible for excessive voltage to be produced on the 'L' terminal, this high voltage can overheat/burnout the relay coil. The relay must be checked for serviceability before installing the replacement alternator. Failure to do so could prevent the replacement alternator from charging.

NOTE. The ignition circuit is used to excite the alternator, not the lamp circuit.
