Replacing the ballast on headlights 88052 and 88053

Vehicle – Audi A4 2000 – 2004 (all models)

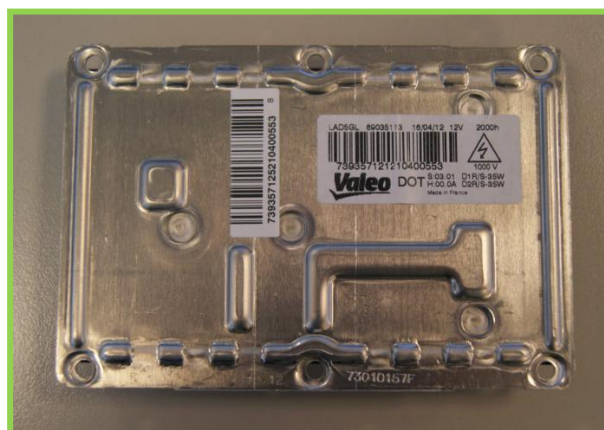
Please note that it is a common indicator when the ballast unit for the xenon headlights for the above vehicle needs replacing the headlights will begin to “blink”. This will be more prominent when driving over uneven surfaces.

If these tests can be completed without any problems occurring, the ballast should be replaced using Valeo part number 88794.
