574304 Wiper linkage seizing

Part Number: 574304

For Vehicle: Audi A6

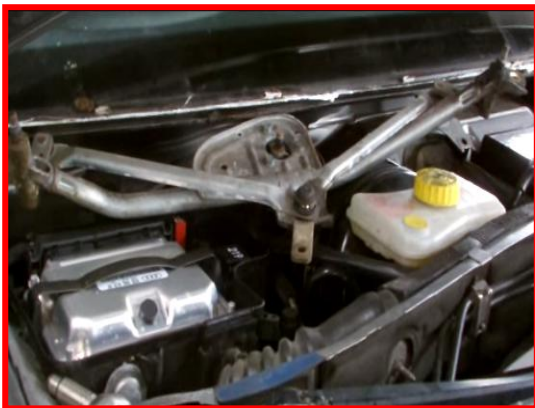
The joint where the wiper linkage connects to the wiper arm is prone to rust and other contamination. When issues with the wiper operation arise it can be a sign that the linkage is beginning to slow due to rust or other contamination. Simply changing the wiper will not cure these symptoms as the linkage will continue to seize and begin to overload the wiper motor causing wider issues. Best practice when replacing 574304 on an Audi A6 is to check the wiper linkage and motor during operation to ensure best performance.

Wiper linkage susceptible to rust and other contamination.
