**T.S.B. No.:**  
**AC No. 6 / 08**

**PRODUCT:**  
**Cimate Control**

**PART No.:**  
**817824**

**SUBJECT:**  
Change to technical  
reference code

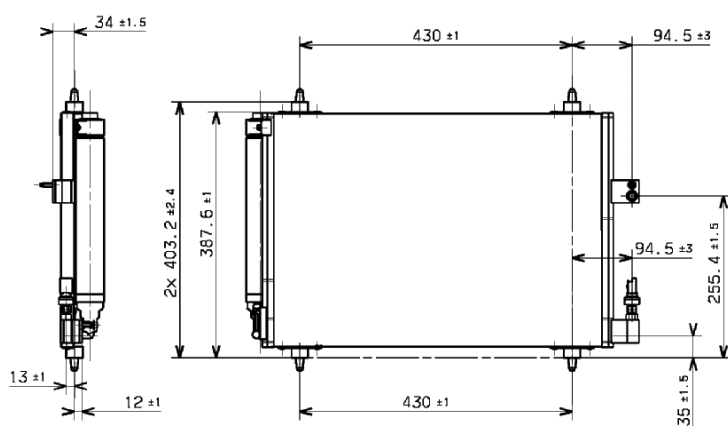
Technical drawing of CA1458

The condenser fitted to the new Citroen C5 2008>, with technical reference code CA1542, measures 3mm less in width to 817824 (CA1458).

817824 reference is maintained but technical code CA1458 is replaced by CA1542.

Valeo Service can confirm that both condensers are interchangeable.

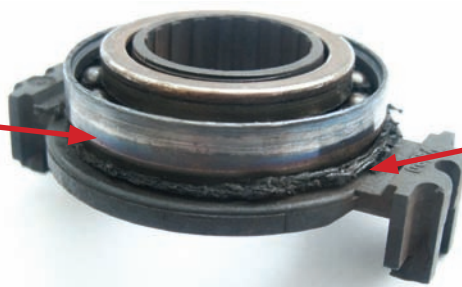
*Image 2*

The cause of the failure is incorrectly diagnosed as a collapsed/failed bearing, however the real cause of the bearing failure is due to thermal damage caused by a preload fault. When the diaphragm fingers are worn to excess and the bearing face does not have a contact point on the diaphragm fingers, the outer race of the bearing will contact the fingers. This causes the outer race of the bearing to turn, resulting in the carrier becoming hot and subsequently melting. (Image 2).

*Contact with the fingers is made at this point, resulting in thermal bluing.*

*Outer race will turn causing carrier to become hot and subsequently melt.*

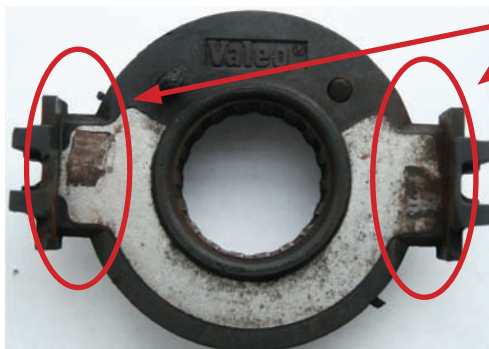
*Image 3*

The rear of the bearing will also display evidence of a heavy contact from the release fork seating pads. Heavy impressions can clearly be seen at the point the bearing locates onto the fork. (Image 3)

*Heavy/deep impression from fork pads.*

This is the result of a heavy contact being applied to the bearing from the release fork being partially seized due to worn pivot point bushes and worn release arm cross shaft. A thorough examination of the release mechanism should be carried prior to the refitting of the gearbox. This Issue is addressed in TSB CL005/08. Clutches returned to Valeo that clearly exhibit evidence of bearing preload will not be accepted under warranty.
