Clutch disengagement failure due to insufficient grease on the gearbox input shaft splines

Part Number: 828154

For Vehicle: Vauxhall Vivaro 1.9d 08/01 > 07/06, Renault Trafic 1.9d 01/03 >

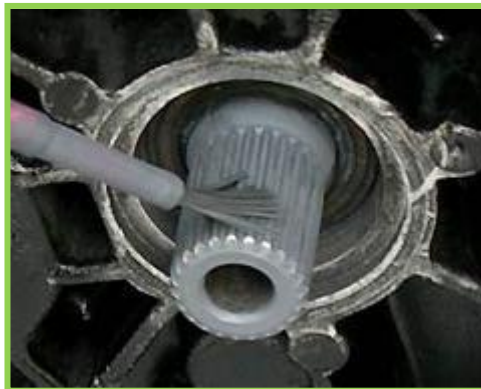
The Valeo Service Technical department have had several claims stating that after fitment of clutch kit 828154 gears cannot be selected.

After investigating the issue Valeo technicians have identified that the clutch kit itself is not at fault and the issue is related to there being insufficient grease on the gearbox input shaft splines. Lightly coating the input shaft splines with a small brush using a correct, high temperature grease suitable for use in clutch environments (OE 90397024) is essential. **Copper based grease is unsuitable for use due to its low viscosity and melting temperatures.** It is important the splines are kept lubricated to avoid rusting and corrosion. Cleaning and re-lubrication of the input shaft splines will also ensure clutch operation is kept smooth.

Do not apply additional grease directly to the splines on the drive plate hub. The grease will be pushed out from the splines during installation of the input shaft and allow it to accumulate on the outside of the hub. Then when the input shaft is rotating at high engine speed the grease will be forced outwards onto the clutch drive plate and pressure plate which could potentially cause judder or clutch slip.

Ensure the gearbox input shaft splines are lubricated when fitting clutch kit 828154
