Issue no. 03/2019: Torn-off valve due to canted valve spring

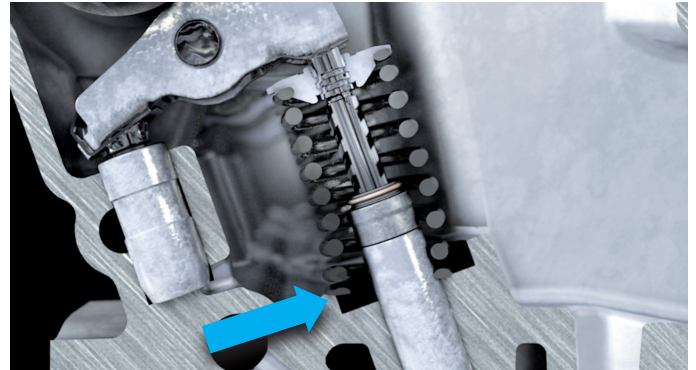
After repair work on the valve train, a valve may occasionally break off during operation under unfavorable conditions. This is generally caused by an assembly error: a valve spring installed at an angle.

If the valve spring is assembled canted unnoticed, uneven forces act on it, because even when the valve is closed, the spring is more compressed on one side. When the valve now opens, the spring is pressed onto the block and the stroke of the camshaft creates a massive bending moment in the upper area of the valve shaft.

Figure 1: Valve spring installed at an angle

When mounting the valve springs, ensure the seat in the cylinder head is correct! If new valves are installed, the valve keys should always be replaced too!

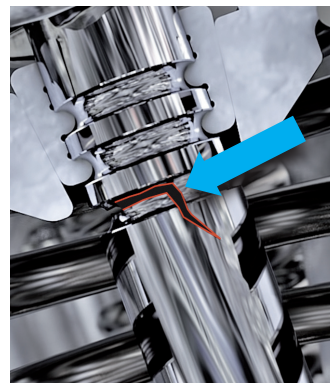
Starting from the lowest groove on the valve shaft, this can cause the valve to be torn off. It then falls into the combustion chamber, becomes trapped between the piston and cylinder head, and is severely deformed.

- The damage occurs immediately after the repair.
- The fracture starts at the top of the third groove and runs across the valve shaft (see Figure 2).
- Valve keys are partially deformed at the partitions.
- There are uneven pressure marks on the contact surfaces of the valve spring in the cylinder head (see Figure 3).
- The fracture surface exhibits the typical structure of a forced rupture (see Figure 4).

Figure 2: Valve fracture at the lowest groove

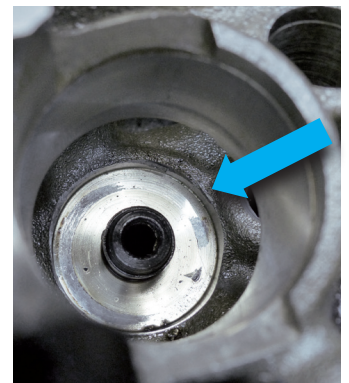
Figure 3: Pressure marks in the cylinder head

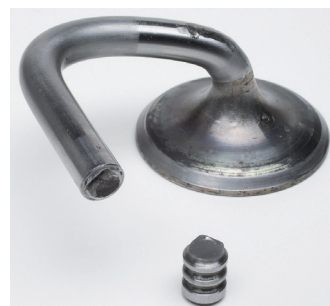
Figure 4: Broken valve

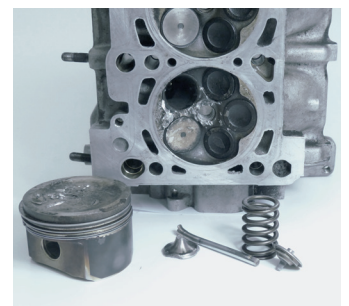
Figure 5: Typical damage scenario after a valve has torn off
