## Heavy duty clutch release arm 2.5 TDi

Part Number: 801255

For Vehicle: Land Rover Defender, Discovery, TDi

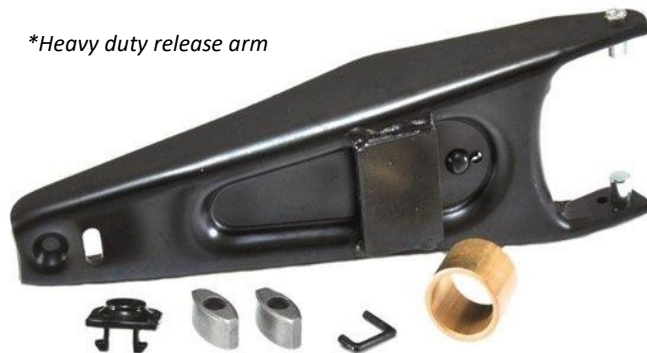
*\*Heavy duty release arm*

After investigating the issue Valeo technicians have identified that the clutch kit itself is not at fault, The most common cause is a worn or faulty clutch release arm. In particular the pivot ball is prone to wear and the release arm is prone to cracking.

Due to issues with the clutch release arm some manufacturers provide a **heavy duty release arm** (with clip, staple retainer, slipper pads and spigot bush). The release arm is reinforced to prevent the pivot ball breaking or the clutch release arm cracking. Valeo recommend the clutch release arm is replaced with a heavy duty release arm (with bearing clip, staple retainer, slipper pads and pivot bush) during every clutch change.

- Clutch release arm (should be replaced with a heavy duty release arm during every clutch change).
- Clutch master cylinder (prone to wear or low oil/incorrect oil).
- Clutch slave cylinder and push rod. (change the push rod during every clutch change).
- Clutch dampener. (dampens vehicle vibration)
- Spigot bearing (replace during every clutch change).
- Check the rear main oil seal for leaks.
