## Troubleshooting - earthing in frame

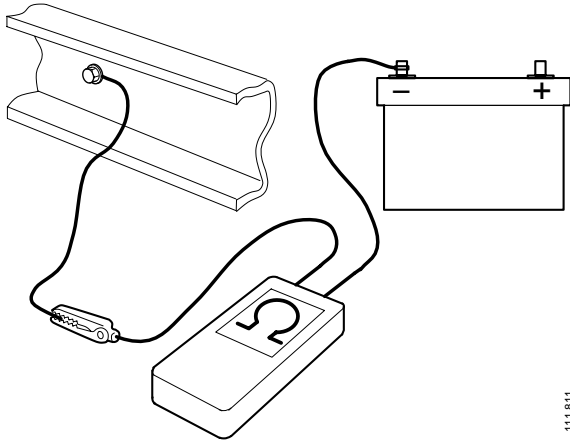
111811

- Readings taken on a screw which has a thin rust-inhibiting coating on its surface may indicate that it does not conduct current. This is perfectly possible as the screw's surface coating consists of a black chromate layer which wears off when the screw is tightened, even if it is not tightened very hard. The screw conducts current just as efficiently as other screws. Take readings on the cable terminal or bare metal instead.
