Modified fog and spotlamp unit

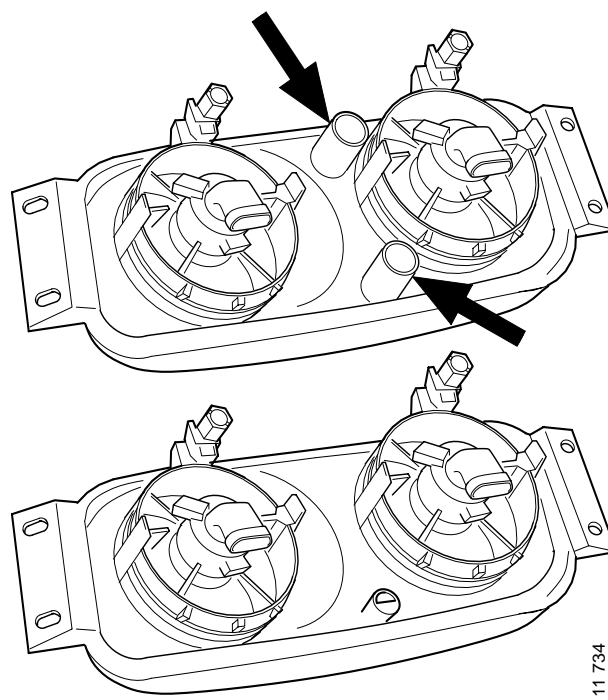
Trouble has been caused by dust and moisture entering the fog and spotlamp unit. The dust and moisture have entered via the two valves at the rear of the unit.

The upper illustration shows the old fog and spotlamp unit with valves.

The lower illustration shows the new fog and spotlamp unit without valves.

Scania has developed a modified fog and spotlamp unit on which the valves have been removed and all ventilation is effected instead via the bulb holders.

Plugs for mounting over the ventilation holes have been developed as a service solution for existing fog and spotlamp units. These plugs will not be fitted on production fog and spotlamp units.
