## Modified fog and spotlamp unit

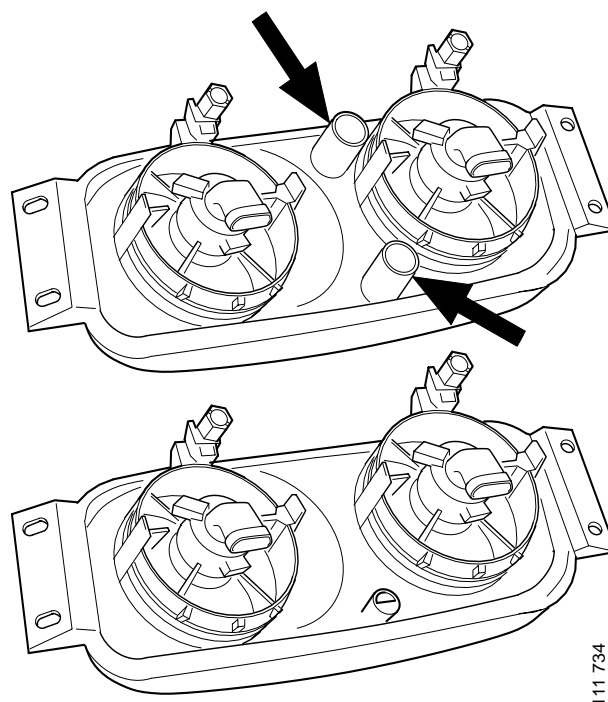
Trouble has been caused by dust and moisture entering the fog and spotlamp unit. The dust and moisture have entered via the two valves at the rear of the unit.

*The upper illustration shows the old fog and spotlamp unit with valves.*

*The lower illustration shows the new fog and spotlamp unit without valves.*

Scania has developed a modified fog and spotlamp unit on which the valves have been removed and all ventilation is effected instead via the bulb holders.

Plugs for mounting over the ventilation holes have been developed as a service solution for existing fog and spotlamp units. These plugs will not be fitted on production fog and spotlamp units.
