## New switch for power windows

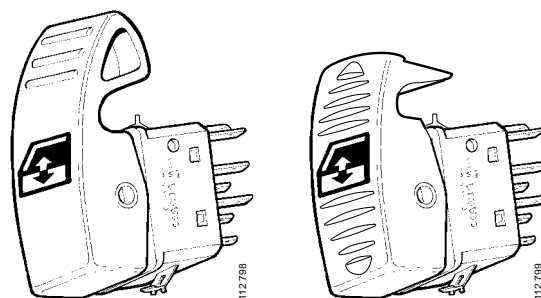
When the driver climbs down from the cab he may catch on the power window switch and the black button may be forced loose. The spring behind the plastic switch also falls out and is lost.

*Old switch.*

*New switch.*

In order to remedy this problem, a new shorter switch has been introduced into production from the following chassis numbers:

- Remove:
  - the switch panel in the door
  - the electrical connector.
- Carefully press in the metal plates which secure the switch to the panel and remove the switch.
- Install
  - the new switch.
  - the electrical connector.
  - the panel in the door.
