New switch for power windows

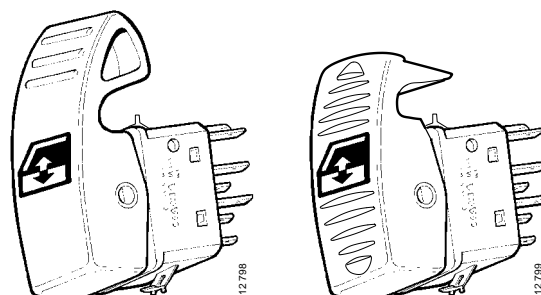
When the driver climbs down from the cab he may catch on the power window switch and the black button may be forced loose. The spring behind the plastic switch also falls out and is lost.

Old switch.

New switch.

In order to remedy this problem, a new shorter switch has been introduced into production from the following chassis numbers:

- Remove:
 - the switch panel in the door
 - the electrical connector.
- Carefully press in the metal plates which secure the switch to the panel and remove the switch.
- Install
 - the new switch.
 - the electrical connector.
 - the panel in the door.
