Earth fault which interferes with the temperature gauge

Applies to DC11 and DSC12.

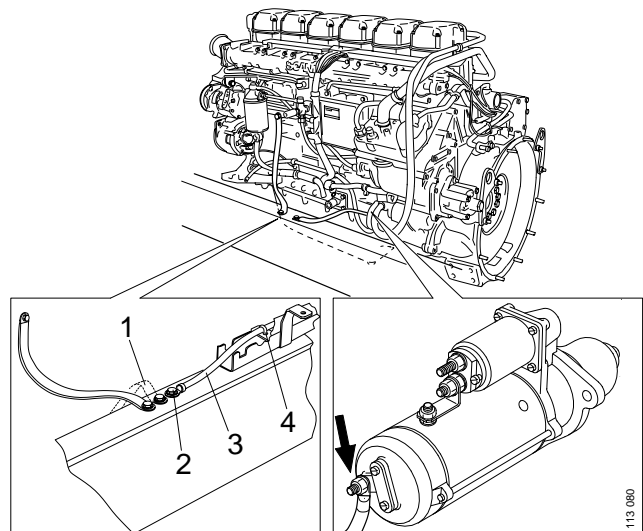
There have been incidences when the coolant temperature gauge has indicated an incorrect temperature. Inadequate earthing between the chassi and the engine is the cause. Currently earthing is achieved between two earth braids which are placed in the engine frame and side-covers.

- 1 *Outgoing earth braid 1 378 852*
- 2 *Screw 813 005*
- 3 *Earth cable 1 378 324*
- 4 *Strap 815 363*

One of the earth braids 1 378 852 is removed in production and replaced by an earth cable. One of the earth cable ends is fitted to an already existing hole in the frame and the other end is fitted to the starter motor, see illustration.

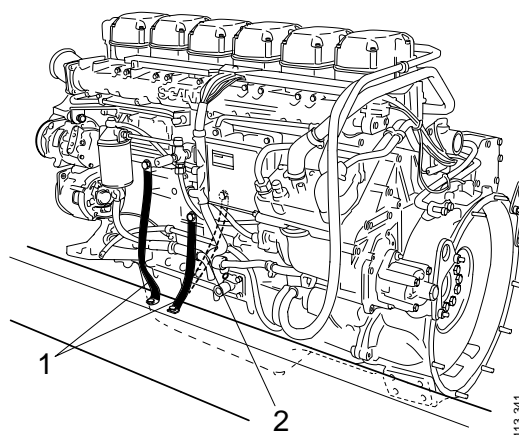
- 1 The old production solution.
2 After the service solution.

Move the rear side cover earth braid to a suitable casting protrusion on the cylinder block. Scrape off the colour on the cylinder block before fitting the earth braid to the new earth point.
