Earth fault which interferes with the temperature gauge

Applies to DC11 and DSC12.

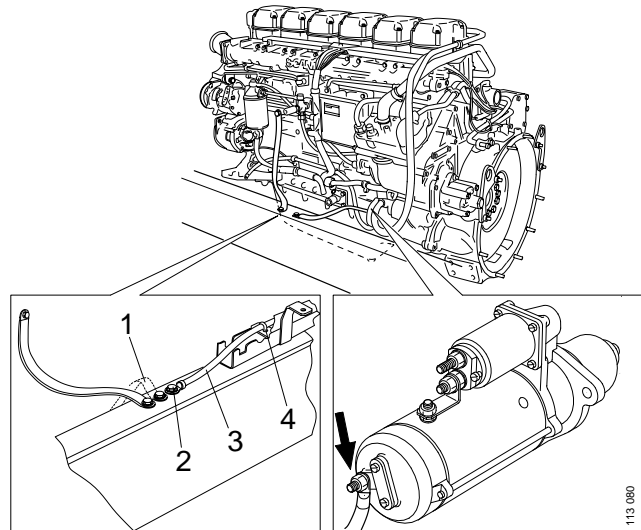
There have been incidences when the coolant temperature gauge has indicated an incorrect temperature. Inadequate earthing between the chassi and the engine is the cause. Currently earthing is achieved between two earth braids which are placed in the engine frame and side-covers.

- 1 *Outgoing earth braid 1 378 852*
- 2 *Screw 813 005*
- 3 *Earth cable 1 378 324*
- 4 *Strap 815 363*

One of the earth braids 1 378 852 is removed in production and replaced by an earth cable. One of the earth cable ends is fitted to an already existing hole in the frame and the other end is fitted to the starter motor, see illustration.

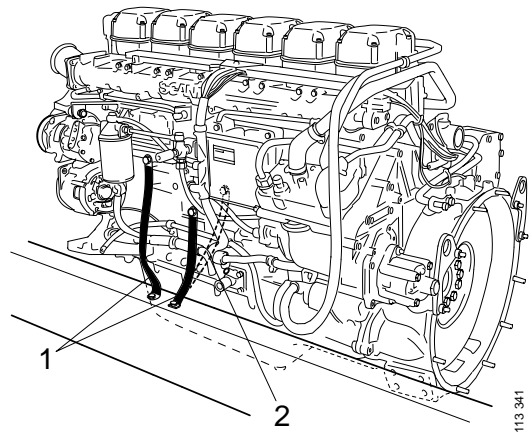
- 1 The old production solution.
- 2 After the service solution.

Move the rear side cover earth braid to a suitable casting protrusion on the cylinder block. Scrape off the colour on the cylinder block before fitting the earth braid to the new earth point.
