New bulb in the roof sign illumination

Applicable to vehicles with roof sign illumination except CR19T.

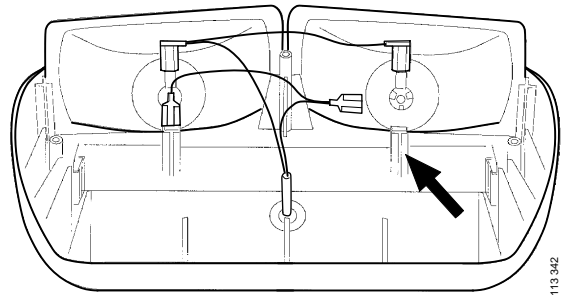
It has been reported that the roof sign illumination bulb has a short service life.

Fig. 1. The old reflectors.

When replacing the old bulb with bulb 21 W HD (Heavy duty), the roof sign illumination reflector must also be replaced.

Note: The plastic retainers must be removed in order to clear enough space for the new reflectors. See illustration 1. The easiest way to do this is with cutting pliers.

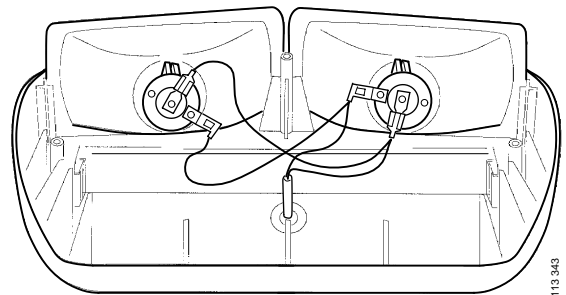
Fig. 2. The new reflectors.

4. Fit the new reflectors with the new bulbs and connect the cables.
5. Reassemble the roof sign illumination.
6. Reconnect the negative cable to the battery.
