New bulb in the roof sign illumination

Applicable to vehicles with roof sign illumination except CR19T.

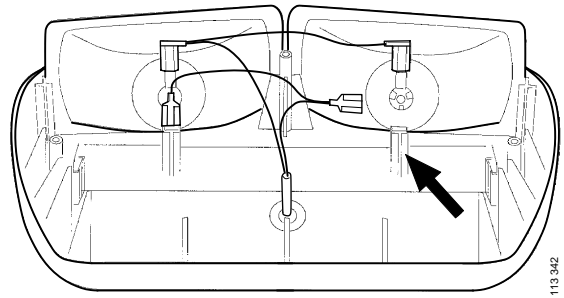
Note: The plastic retainers must be removed in order to clear enough space for the new reflectors. See illustration 1. The easiest way to do this is with cutting pliers.

Fig. 1. The old reflectors.

1. Disconnect the negative cable from the battery.
2. Open the roof sign illumination and disconnect the cables.
3. Remove the reflectors and the sheets for positive supply from the plastic retainers.

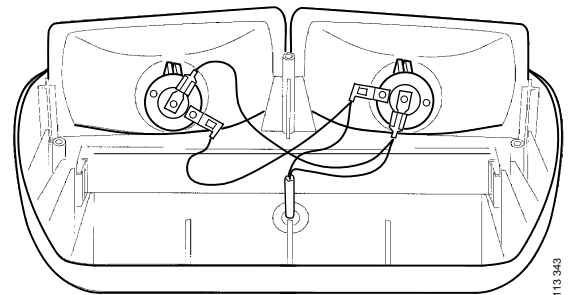
Fig. 2. The new reflectors.

When replacing the old bulb with bulb 21 W HD (Heavy duty), the roof sign illumination reflector must also be replaced.

4. Fit the new reflectors with the new bulbs and connect the cables.
5. Reassemble the roof sign illumination.
6. Reconnect the negative cable to the battery.
