Short life span of roof sign lighting bulbs on CR19T

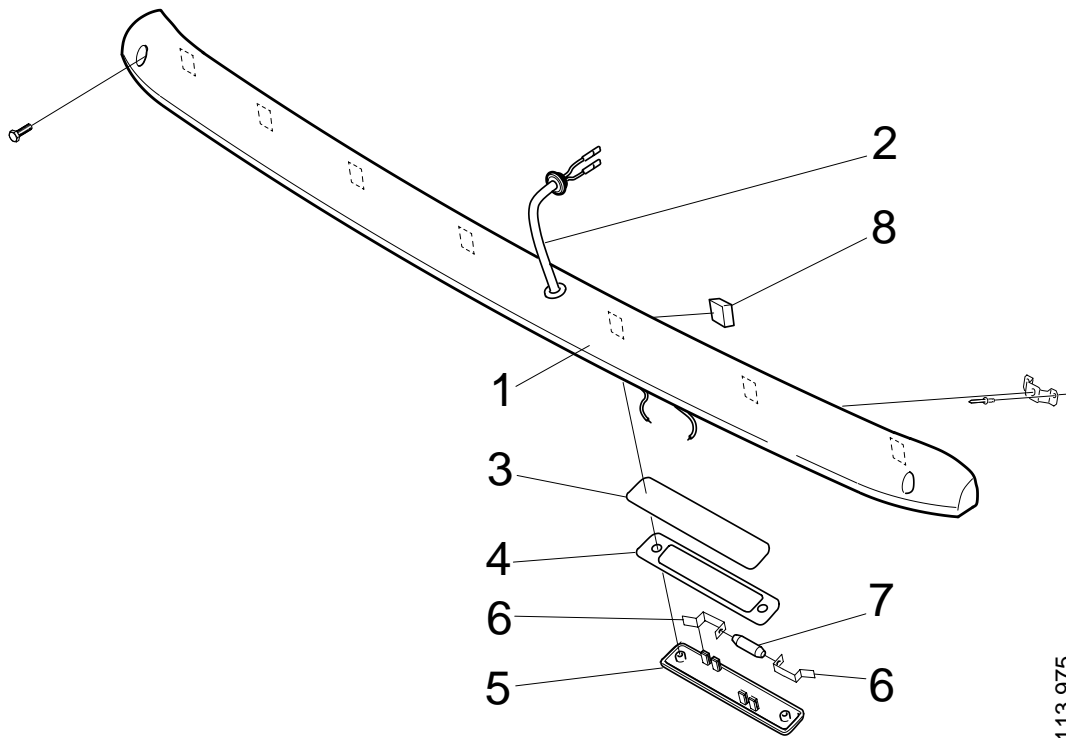
113 975

Bulbs in the roof sign lighting are shown to have a short life span.

To increase the life span of the bulbs, the voltage has been reduced, by means of a resistor, built into the cable harness. To compensate for loss of brightness from the bulbs, a reflector is added.

The new roof sign lighting also has improved lenses, new gaskets and improved vibration dampers.

1. Disconnect the cable from the batteries negative terminal.
2. Remove the roof sign lighting according to the Service handbook 18:01-08.
3. Open the roof sign lighting and disconnect the cables from their connections.
4. Remove the cable harness from the roof sign lighting.
5. Fit the new cable harness. Ensure that the

resistors cables are not stretched.

6. Fit the gaskets and lenses.
7. Fit the bulb holders to the lenses and screw the lenses onto the roof sign lighting.
8. Fit the extra vibration dampers to the rear of the roof sign lighting.
9. Re-fit the roof sign lighting onto the cab according to the Service handbook 18:01-08.
10. Reconnect the cable to the batteries negative terminal.
