16 TI 16-99 02 17 T

Short life span of roof sign lighting bulbs on CR19T

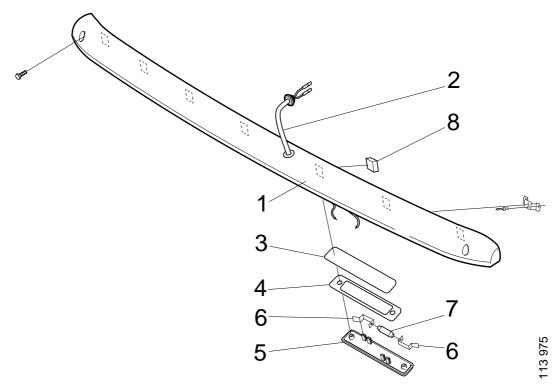
Bulbs in the roof sign lighting are shown to have a short life span.

To increase the life span of the bulbs, the voltage has been reduced, by means of a resistor, built into the cable harness. To compensate for loss of brightness from the bulbs, a reflector is added.

The new roof sign lighting also has improved lenses, new gaskets and improved vibration dampers.

- 1. Disconnect the cable from the batteries negative terminal.
- 2. Remove the roof sign lighting according to the Service handbook 18:01-08.
- 3. Open the roof sign lighting and disconnect the cables from their connections.
- 4. Remove the cable harness from the roof sign lighting.
- 5. Fit the new cable harness. Ensure that the

resistors cables are not stretched.

- 6. Fit the gaskets and lenses.
- 7. Fit the bulb holders to the lenses and screw the lenses onto the roof sign lighting.
- 8. Fit the extra vibration dampers to the rear of the roof sign lighting.
- 9. Re-fit the roof sign lighting onto the cab according to the Service handbook 18:01-08.
- 10. Reconnect the cable to the batteries negative terminal.
