Loss of throttle actuation in trucks with EDC, CAG and Scania retarder

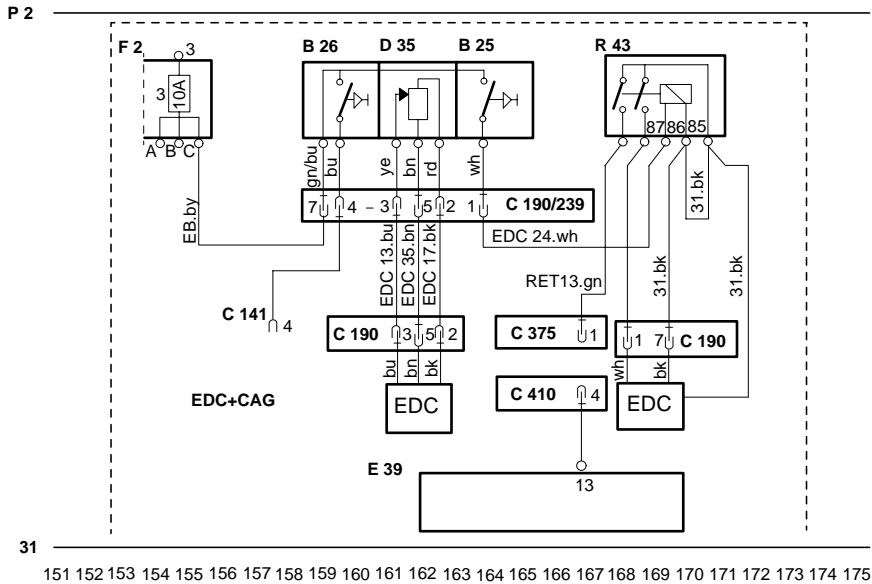
Before modification

This problem is caused by the interaction between the throttle pedal sensor, part number 1 308 297, and relay R43, part number 326 320.
