No throttle actuation in trucks with EDC and Scania retarder

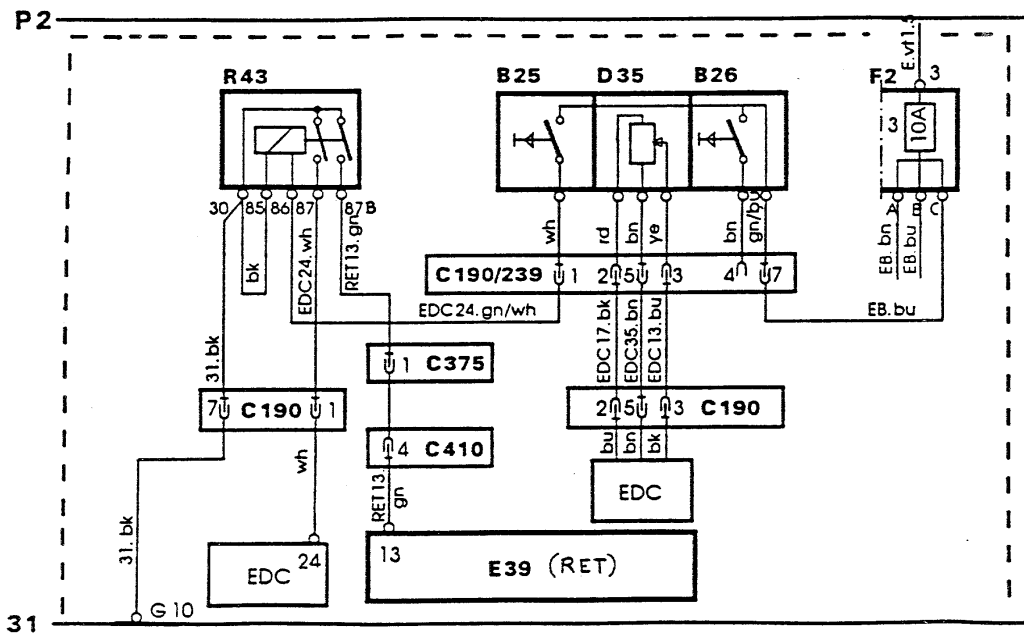
Fig. 1 Before modification

Trucks equipped with EDC and Scania retarder can have problems with loss of throttle actuation. This problem is characterised by the engine dropping to raised idling (~ 700 rpm) when the throttle is actuated. The engine does not react to throttle actuation for a couple of seconds.

The cause of the problem is the interaction between the throttle pedal sensor, part No. 1 104 800, and relay R43, part No. 326 320.

In order to alleviate this problem, relay R43 should be replaced with a diode unit, see work description. The throttle pedal sensor must also be changed. This solution is only for trucks with EDC and Scania retarder.

See the wiring diagrams in figs. 1 and 2 which show connection before and after modification.
