No throttle actuation in trucks with EDC and Scania retarder

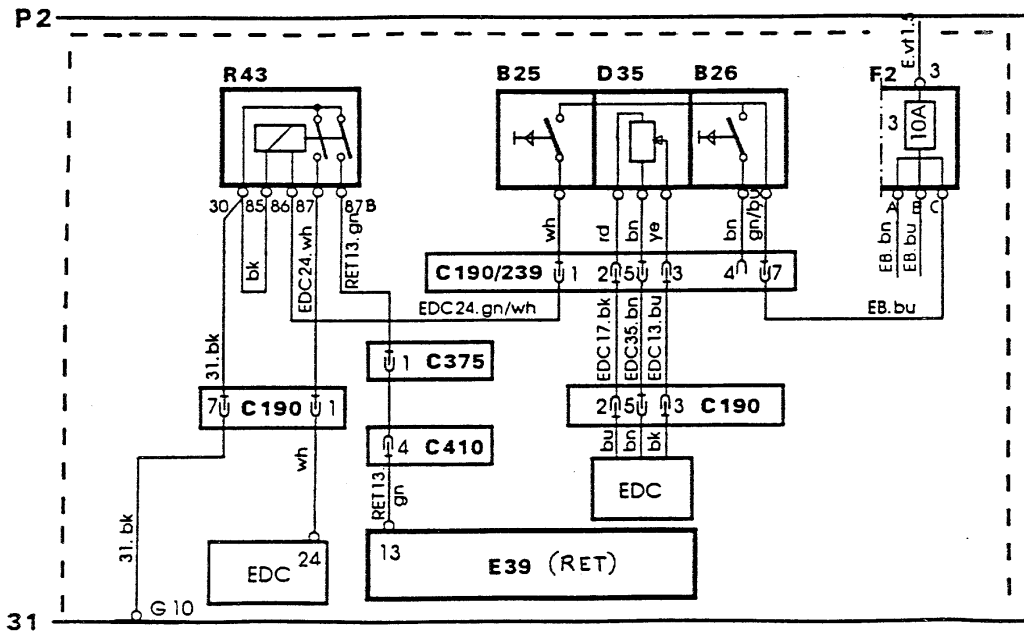
Fig. 1 Before modification

The cause of the problem is the interaction between the throttle pedal sensor, part No. 1 104 800, and relay R43, part No. 326 320.
