Cost-effective repair solutions!

febi no. 33745

Suitable for Mercedes-Benz M Class (163)

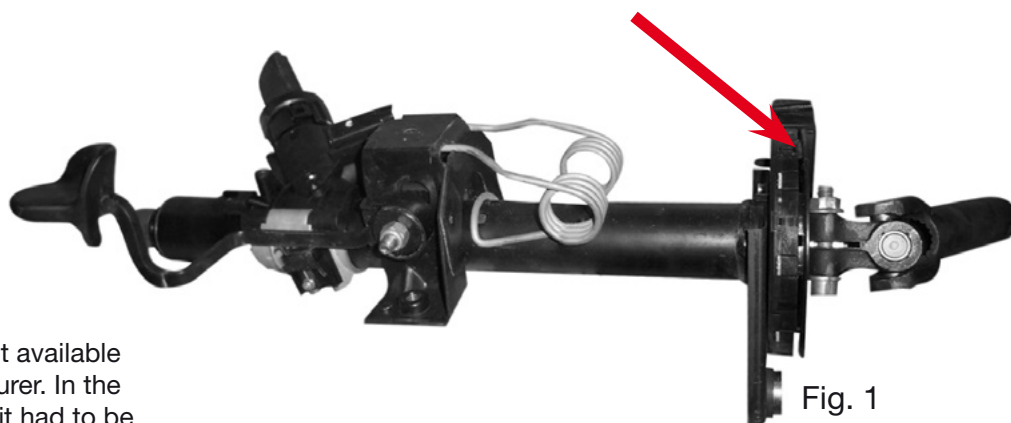
Fig. 1

Steering angle sensors are not available separately from the manufacturer. In the past, if the sensor failed then it had to be replaced along with the whole jacket tube (Fig. 1).
