FORD 1.8 D / Synchronous Drive / Installation Info.

GATES REFERENCE:
5541XS & related kits.
MAKE :
MODEL :
FORD / MAZDA.
 121, C-Max, Courier, Fiesta, Focus, Galaxy,
 Mondeo, S-Max, Tourneo, Transit.

1.8 TD, TDCI, TDDI (all 8 valves).
 Multiple.

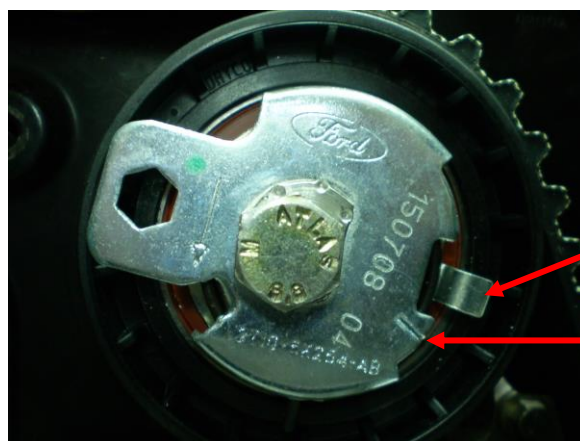
Fig. 1a

Indicator in middle
 of the slot. ✓

Mark on the tensioner

- 1) The engine must be cold: the engine temperature significantly influences the installation parameters.
- 2) The engine must be at TDC. All engine specific setting & locking tools can be found in Gates tool kit GAT4830.
- 3) The crankshaft has to be locked (when equipped with air conditioning, the alternator shaft has to be removed, 6 bolts to loosen).
- 4) The camshaft has to be blocked (at the back of the engine).
- 5) The camshaft sprocket bolt has to be loosened. Make sure the sprocket is free to rotate on the taper, by using the sprocket remover in tool kit GAT4830 (if not done so, the belt will not be tensioned in the top span).
- 6) Turn the tensioner anticlockwise, until the indicator is in **the middle of the slot** (not lined up with the mark on the tensioner). (Fig. 1)

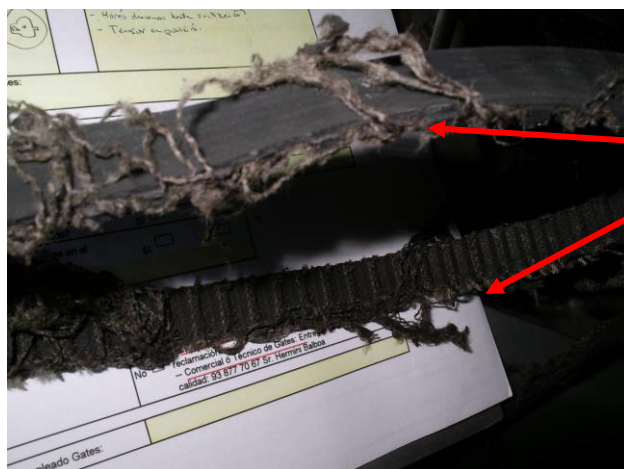
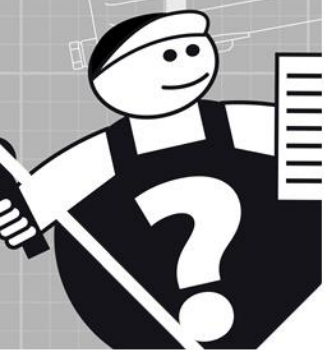
Fig. 2

Failure to do all the above will lead to wrong tension, with possible tracking of the belt as a result. The belt will climb over the camshaft sprocket flange, running into the timing cover (Fig. 2 and Fig. 3).

Typical wear pattern of the side of the belt

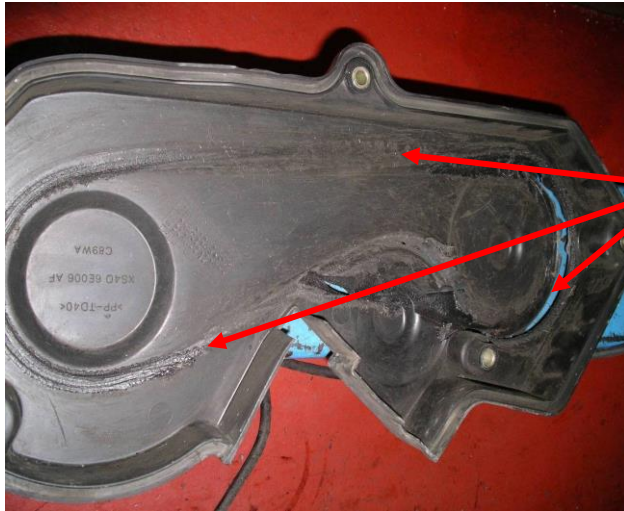
Fig. 3

Signs of serious wear on inside of the cover due to contact with the side of the belt

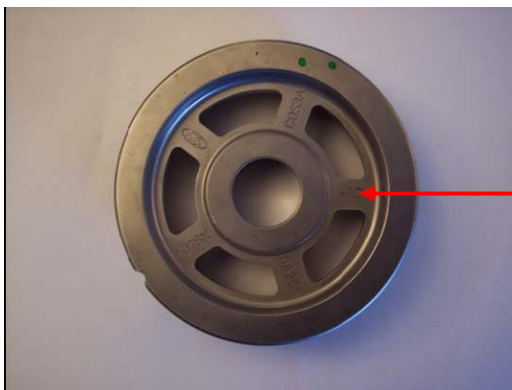
Fig. 4

Extension AC

Check if the part number of the camshaft pulley ends with **AC** (Fig. 4). In case the part number of the camshaft pulley ends with **AB**, fit a new sprocket with OE ref. XS4Q6A256**AC**.

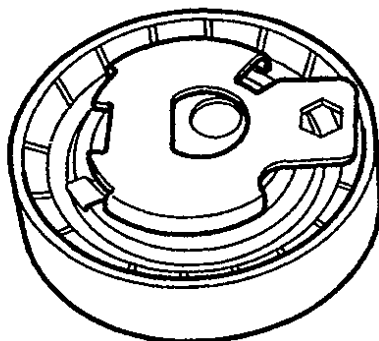
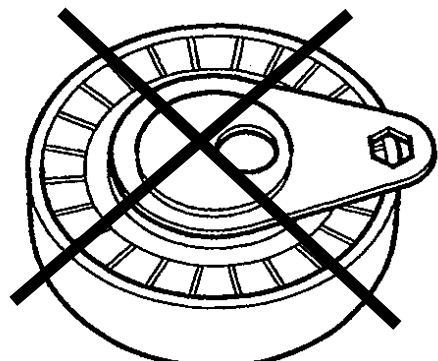
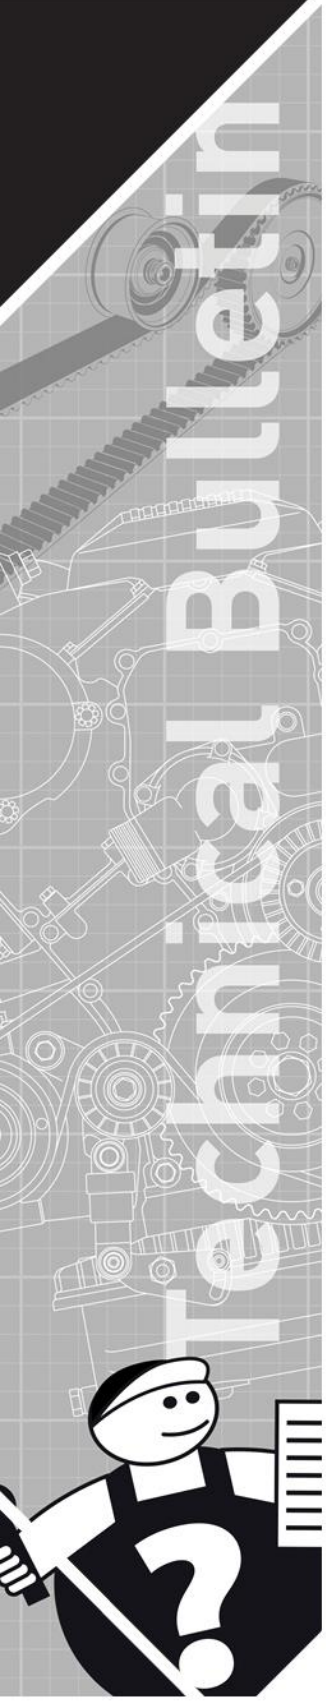
New automatic tensioner

Old manual tensioner

Fig. 5 shows the initial manual tensioner on the right side and the current automatic tensioner on the left.

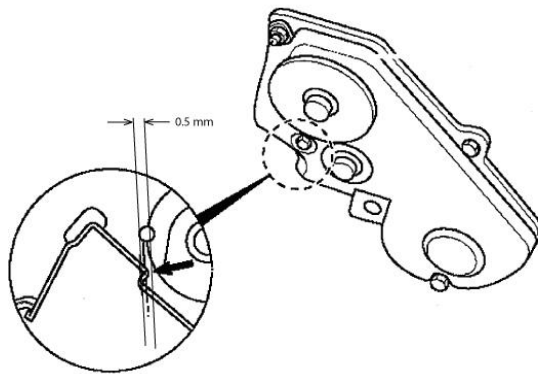
Fig. 6

When the manual tensioner is replaced by an automatic tensioner, the timing belt cover has to be slightly modified.

File off the inner corner (0.5 mm) as shown in Fig. 6.

Do not damage the timing belt cover by filing off too much of the corner!
