Condensation in light units

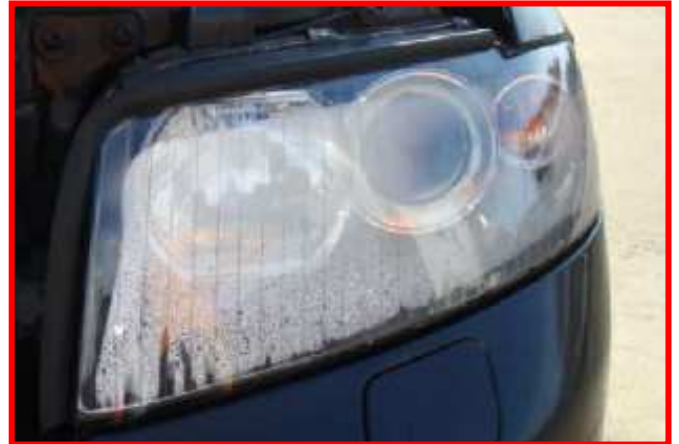
When a filament bulb is illuminated, the heat generated from it evaporates the moisture, and the increase in pressure forces the air out through the vents producing an undisturbed light pattern. When the bulb is switched off the cooling atmosphere in the lamp causes a drop in air pressure, drawing air and moisture back into the lamp. Once this moisture contacts the cooling surface inside the lamp, it condenses and causes an opaque lens.

Example of a headlamp with moisture on the lens

This is an accepted occurrence in light units and does not affect the performance or life span on the lens. A light unit is designed with ventilation ports to allow air to escape freely when there are differences in air pressure.

If the condensation is not evaporated away from the lighting surface or droplets of moisture are inside the lamp, excess moisture will need to be dried away and the lamp conditions closely monitored. If this reoccurs, the light unit could be damaged, allowing too much moisture to enter and should be replaced.
