FBK862 Transit V 2000-06 Transit Tourneo 2002>

WBTB 0003

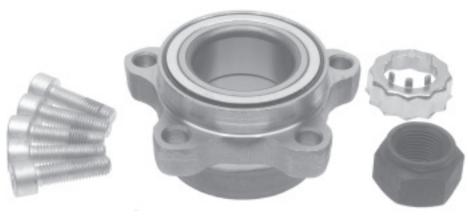
To prevent premature failure of this bearing assembly it is essential that the vehicle manufacturers' service data is strictly adhered to and that the correct service tools are utilised during the repair operation.

Under no circumstances should an impact wrench be used to remove or tighten the driveshaft retaining nut.

Following renewal of the hub bearings the driveshaft retaining nut must be tightened in 5 stages.

- 1) rotate the wheel 5 times
- 2) tighten the retaining nut to 250Nm.
- 3) rotate the wheel 5 times
- 4) fully tighten the retaining nut to 420Nm.
- 5) rotate the wheel 5 times

Finally, install the retaining nut lock ring and fit the new split cotter pin.
