TROUBLESHOOTING GUIDE

**FOR MICRO-V[®] XF
MULTI-RIBBED BELTS**

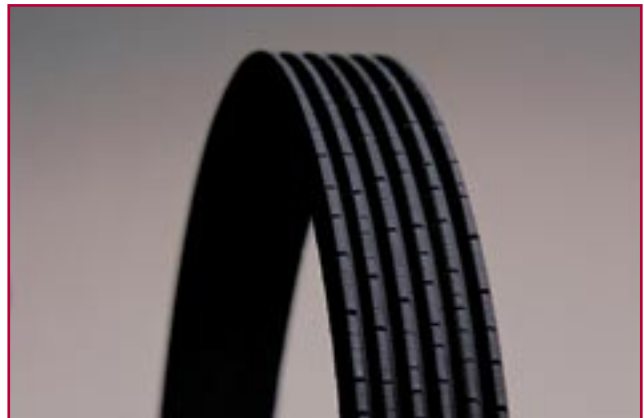
1. RANDOM CRACKING ACROSS THE RIBS

Appearance: Small yet visible cracks along the length of a rib or ribs.

Cause: In addition to continuous exposure to high temperatures, the stress of bending around the pulleys leads to cracking. Cracks begin at the rib top and grow to the cord line. As a rule, if cracks appear 1 or 2 cm apart, 80% of the life is gone and the belt should be replaced.

Solution: Replace with a Gates Micro-V® XF belt, which is engineered to withstand higher temperatures and resist cracking.

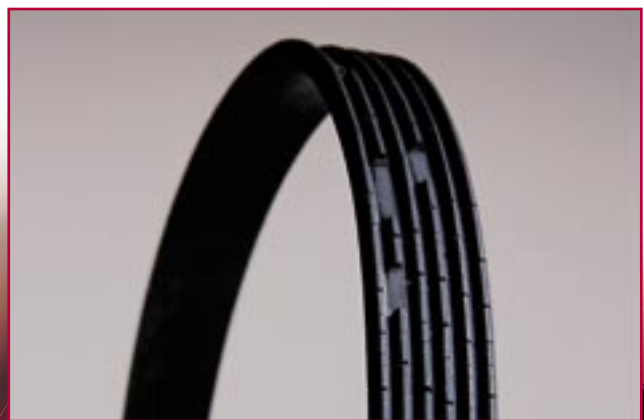
2. CHUNK-OUT

Appearance: Pieces or chunks of rubber material have come off the belt. When chunk-out has occurred, a belt can fail at any moment.

Cause: Chunk-out can happen when several cracks in one area move parallel to the cord line. Heat, age and stress are the primary contributors.

Solution: Replace the belt immediately with a Gates Micro-V® XF belt. Gates belts are designed for greater flexibility and heat tolerance in today's smaller engine compartments.

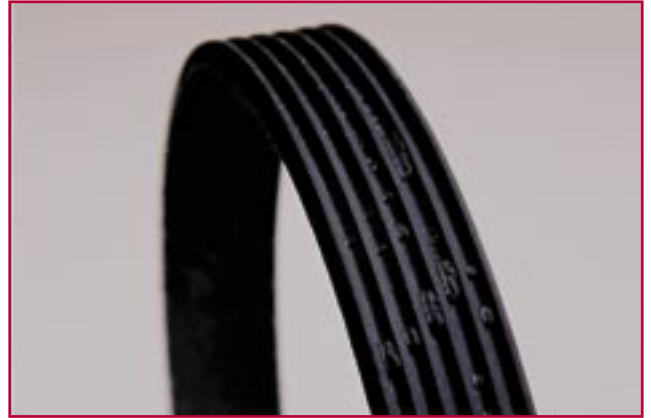
3. PILLING

Appearance: Belt material is sheared off from the ribs and builds up in the belt grooves.

Cause: There are a number of causes, including lack of tension, misalignment, worn pulleys or a combination of these factors. Pilling will occur most frequently in diesel engines, but is not isolated to them.

Solution: When pilling leads to belt noise or excess belt vibration, the belt should be replaced.

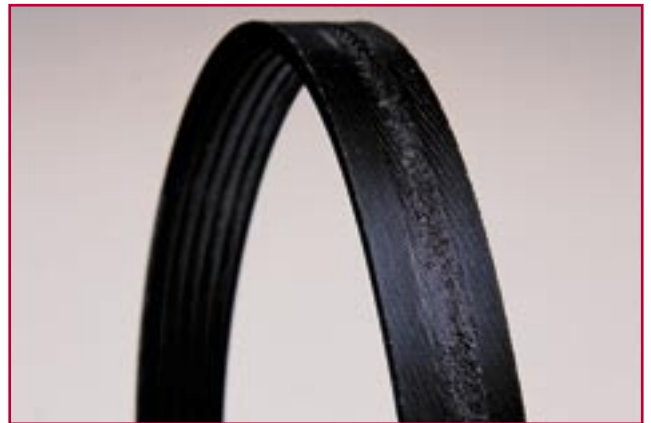
4. ABRASION

Appearance: Back side of belt appears shiny or glazed. In advanced stages, the fabric becomes exposed.

Cause: When in motion, the belt makes contact with an object in its path such as a flange or bolt. This may be caused by improper belt tension.

Solution: Replace the belt and remove the foreign object or, if it can't be removed, make sure that contact is avoided. Check the belt tensioner and ensure proper belt tension.

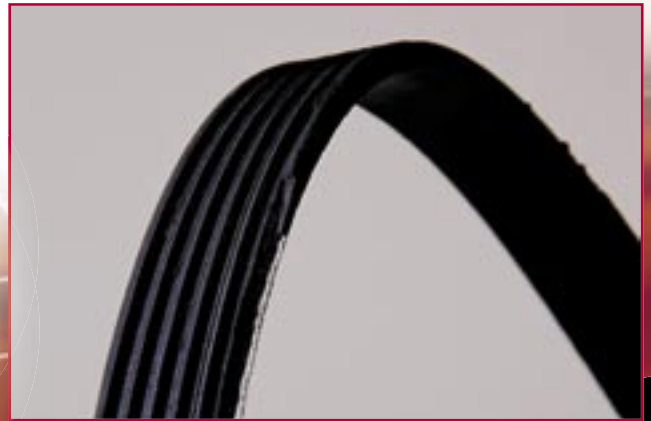
5. DAMAGED OUTERMOST BELT RIBS

Appearance: Sidewalls of the belt may appear glazed or the edge-cord may become frayed and ribs removed. A noticeable noise may result. In severe cases, the belt can jump off the pulley.

Cause: Pulley misalignment is a common cause of premature belt failure. Misalignment forces the belt to kink or twist while running, causing premature wear.

Solution: Replace the belt and make sure to realign the pulleys. Also check that the pulleys, pulley brackets and shafts are not bent or broken.

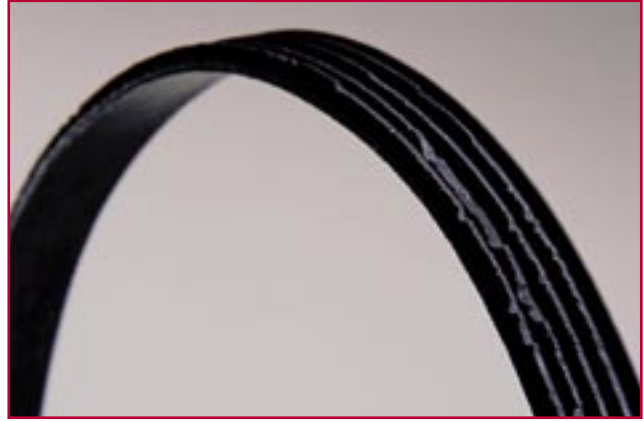
6. UNEVEN RIB WEAR

Appearance: Damage to the side of the belt, a possible break in a tensile cord or jagged ribs. A thumping or grinding noise may also be heard.

Cause: A foreign object – such as a pebble – in the pulley will cause uneven wear and can cut into the belt and break the tensile cords.

Solution: Replace the belt and inspect the pulley for foreign objects or damage. Replace the pulley if necessary.

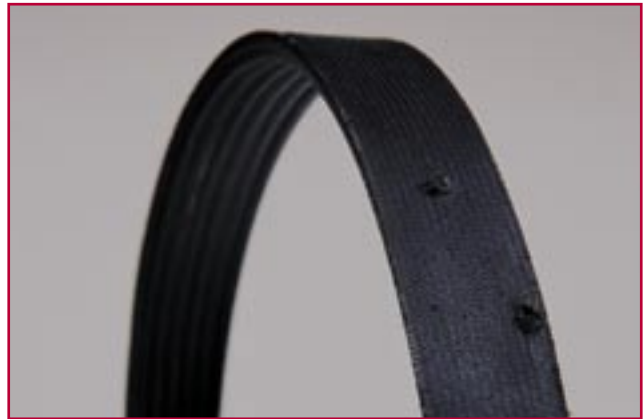
7. GRAVEL PENETRATION

Appearance: Small pinholes are visible on the back side of the belt. Bumps may be visible and fabric around the holes can be frayed.

Cause: Pebble, gravel or sand is wedged between the belt groove(s) and pulley ridge(s).

Solution: Clean the drive and then replace the belt to avoid tensile cord separation and possible roadside failure. Use Gates Micro-V® XF belts, which are precision ground in the factory for a better pulley fit.

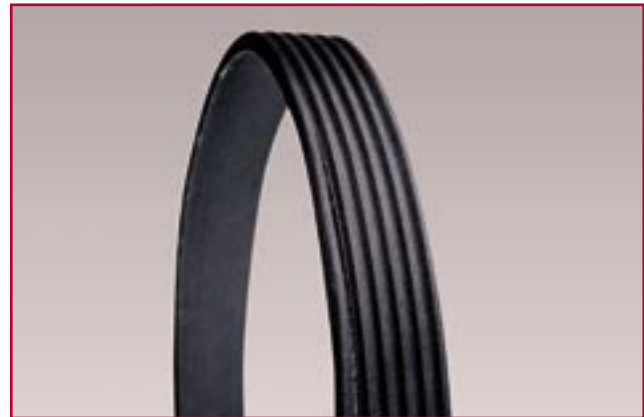
8. RIB SEPARATION

Appearance: A belt rib begins to separate from the joined strands. If left unattended, the cover will often separate, causing the entire belt to unravel.

Cause: The belt is not correctly positioned. One of the belt ribs is placed outside the pulley groove, causing a belt rib to run without a supporting or aligning pulley groove.

Solution: The belt's life has been severely limited, so the belt should be replaced immediately. Make sure all ribs of the replacement belt fit into the pulley grooves. Run the engine and then, with the engine off and battery disconnected, inspect the belt for proper installation.

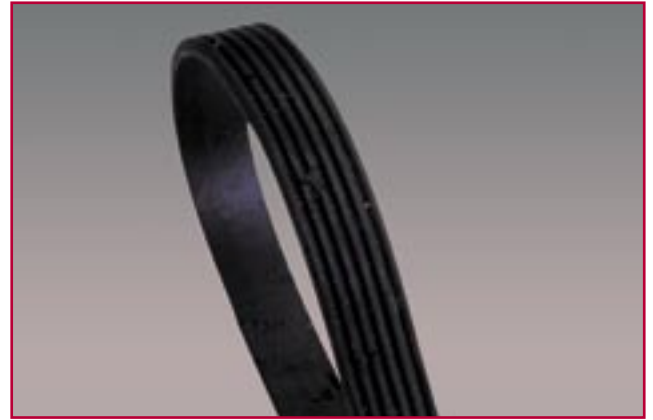
9. OIL CONTAMINATION

Appearance: The belt surface is flaky, sticky or swollen.

Cause: Oil and grease are a rubber compound's worst enemies, weakening the compound's bonds and making the belt soft and spongy. Eventually, such a belt will slip, create heat and fail.

Solution: Eliminate sources of oil, grease or chemical contamination. Replace the belt. Do not use belt dressing.

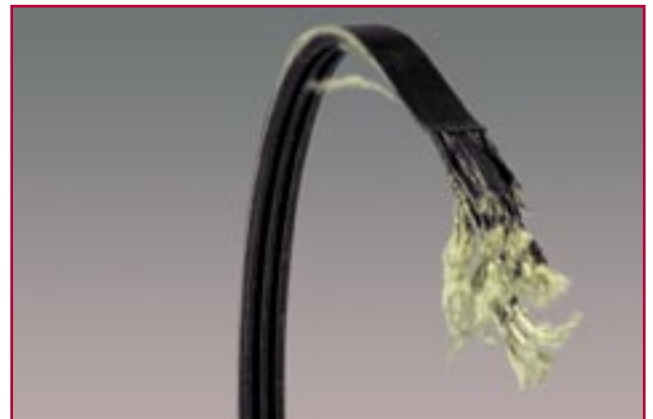
10. BROKEN BELT

Appearance: The belt is broken.

Cause: A large foreign object in the pulley can cut into the belt and break the tensile cords. A tensile break may occur but go unnoticed when the belt is forced or pried on during installation. Other possible causes may be severe shock loads or a blocked pulley and/or accessory.

Solution: Carefully check all components of the drive for foreign objects and damage. Replace them if necessary. Make sure not to force the belt onto the drive with unsuitable tools.

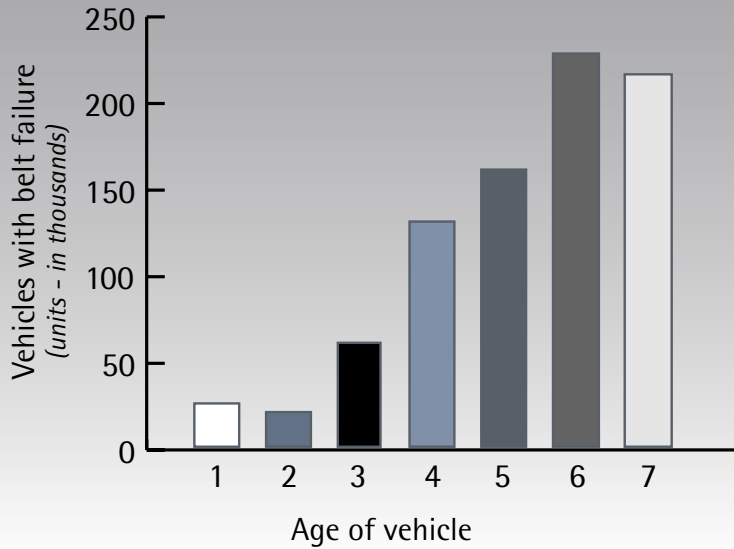
FAILURE OCCURRENCE

This chart illustrates how the incidence of belt failure increases dramatically after the fourth year in operation. To help motorists avoid unpleasant and hazardous situations, replace the multi-ribbed belt with a Micro-V® XF belt if it is four years old or older.

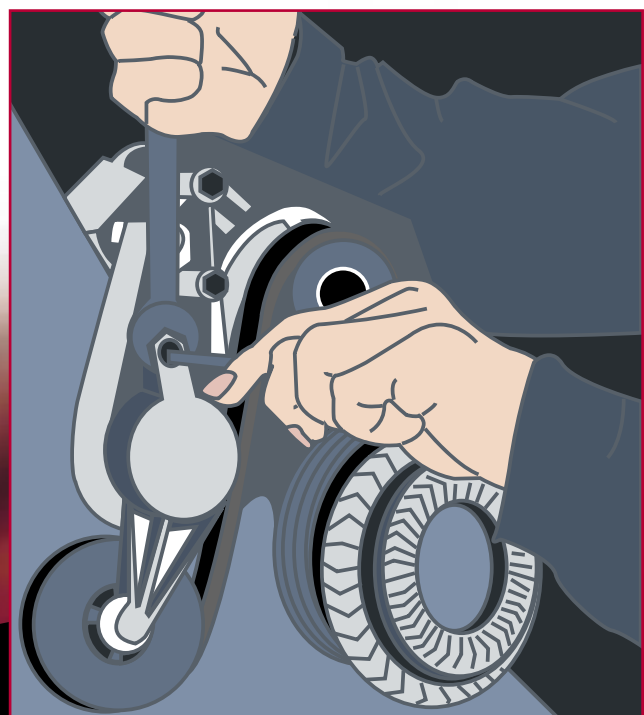
Many new cars use an automatic tensioner which makes servicing easy. Release the tension by means of a spanner or socket wrench and block the tensioner in the retracted position.

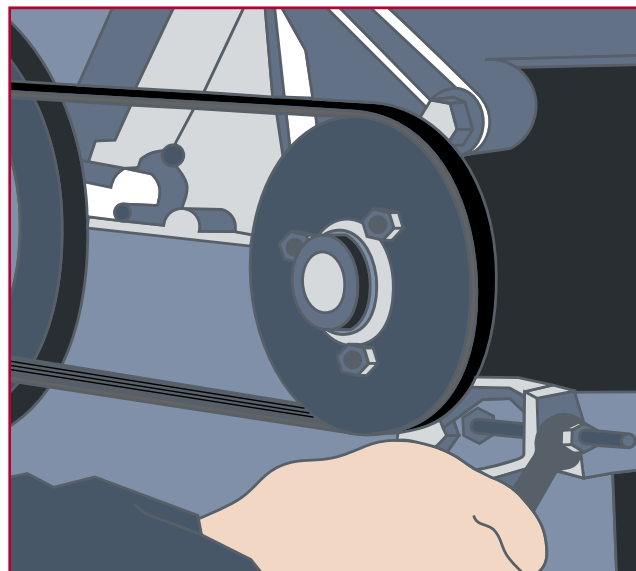
Other cars use tensioners or accessories which have to be locked down manually to provide the correct tension. These are called locked centre drives. To remove the belt, release the tension by loosening the jackscrew.

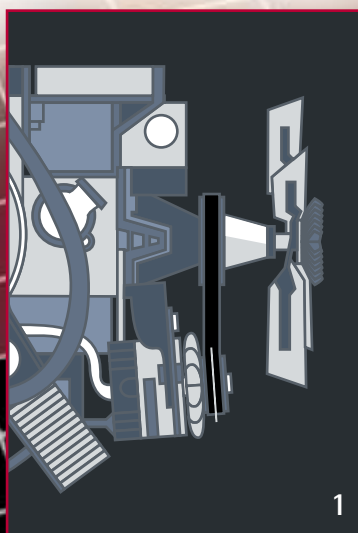
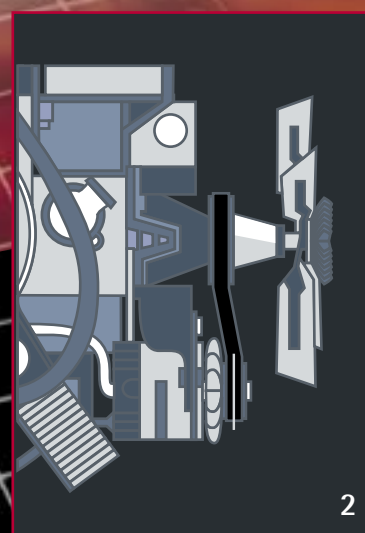
STEP 4 – *Check for misalignment*

While replacing the belt, check the alignment of the pulleys as this is a very critical factor for multi-ribbed belts. Misalignment can cause severe belt wear and damage. It can also create noise or cause belts to jump off the pulleys. Misalignment can be caused by non-parallel shafts on drive accessories (*picture 1*) or pulleys located incorrectly on the shafts (*picture 2*). If misalignment is due to non-parallel shafts, it may be caused by a damaged accessory bracket. Replace the bracket if necessary. The accessory pulley may be seated too far forward or backward on the shaft. In this case,

Misalignment is now easy to diagnose thanks to Gates DriveAlign™ laser alignment tool, which allows you to identify the two most common types of misalignment in serpentine belt systems, even in the tight confines of the engine compartment. Simply position the tool within the grooves of a pulley and aim its bright laser beam at an opposite pulley. Any misalignment is instantly visible. This exclusive lightweight and easy-to-use Gates tool is compatible with all automotive serpentine belt drives.

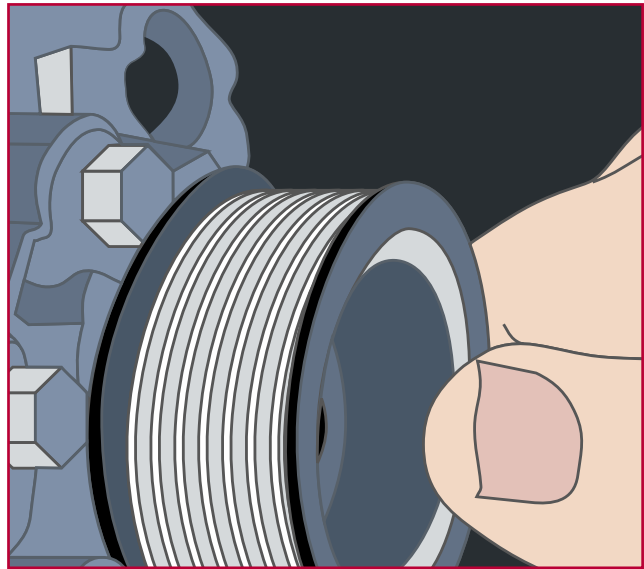
STEP 5 – *Check belt and pulleys for wear and dirt*

Once you have checked alignment, you can remove the belt. Now carefully inspect the entire ribbed area for cracking, chunking and pilling as described earlier in this brochure. Clean the pulleys and tensioners with a solvent and check them for signs of abnormal wear. To check the condition, press a small amount of plasticine firmly into the grooves. The edges of the impression should be straight and the tips even with no distorted points.
