810021 assembly information

Part Number: 810021

For Vehicle: Volkswagen applications

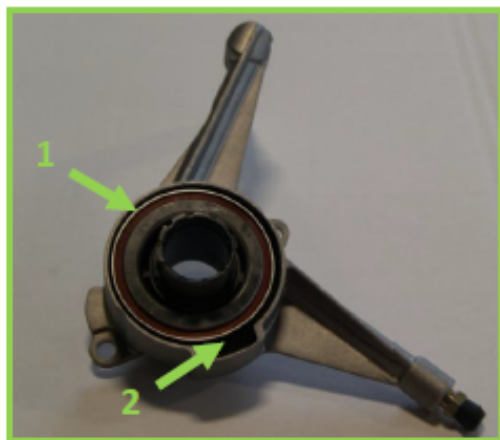
Arrow 1 points to the red line surrounding the circumference of the bearing. Arrow 2 points to the fitment of the bearing not protruding out of the CSC housing. This conforms to specification and should be the condition the concentric slave is in when fitted.

Condition the concentric slave cylinder should be in before fitment

In order to prevent damage to the transmission, and potentially to the clutch, it is necessary to ensure the positioning of the release bearing in concentric slave cylinder 810021 is correct. If incorrectly fitted the release bearing can grind on the diaphragm fingers and the thrust block grinds on the edge of the CSC housing. Although all Valeo components undergo a 100% inspection on the assembly line we have received reports through the Technical hotline whereby during pre inspection of the part the release bearing has been detached from the concentric slave cylinder and fitted back in the incorrect way.

To ensure the release bearing is fitted correctly within the CSC, see the image adjacent and check your part conforms before fitment.

Any claims submitted with the damage pattern shown when the unit is fitted incorrectly would not be covered under the Valeo warranty agreement.
