BMW Crankcase Breather Kit

febi no.: 34830
OE no.: 11 12 7 799 367
Fits: BMW 1 Series (E87) /
3 Series (E46, E90, E91) / 5 Series
(E60, E61) / X3 (E83)
Engine M47N/M47N2

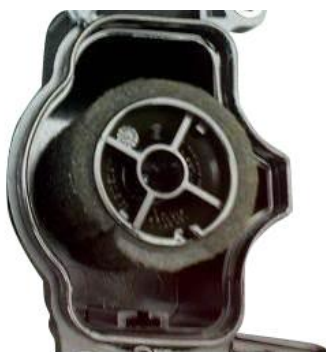
Figure 1: Blocked Filter Element

The original breather has an oil separator filter element inside (to separate the crankcase gasses before the gas is fed back into the inlet for burning off). This element is prone to blocking from oil particles (see figure 1), resulting in excess crankcase pressure. This pressure then blows oil out past the turbo shaft seal, creating the impression of a failed turbo.

febi bilstein recommends replacing the old style crankcase breather kit with the most up to date vortex version (febi 34830), as these are less prone to blockages.

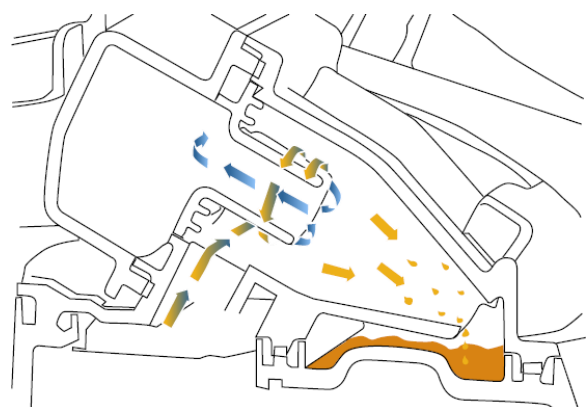
Figure 2: Vortex style Crankcase Breather

The air enters the crankcase breather and as it hits the top it condenses, causing the oil to trickle down the sides and out into the oil tray underneath (to be recirculated within the engine). The air is forced out of the top of the crankcase breather & recirculated into the inlet manifold (see figure 2).
