Aluminium Wheel Cylinder

Product improvement of aluminium wheel cylinder range.

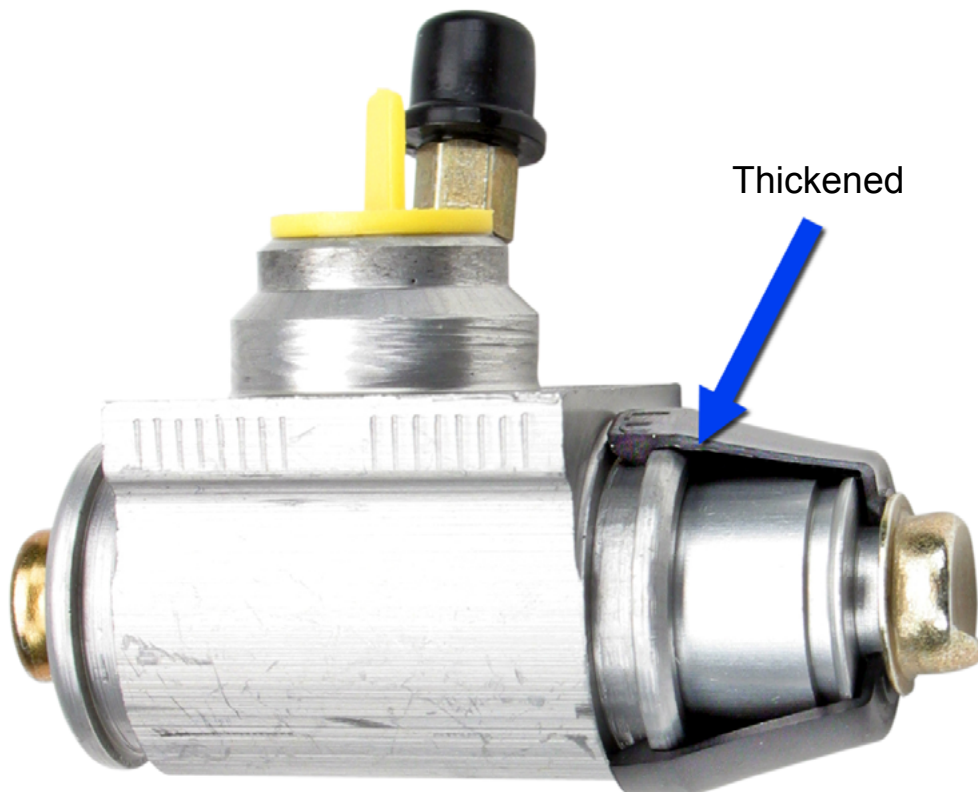
Due to our constant field observation we have found out that in very few cases while fitting Brake Shoes some dust caps were pushed from their seat. Water may penetrate in and could cause leakage of the wheel cylinder.

To improve the safety of the repair quality and to prevent that the dust caps are pushed from the seat during repair, we thickened the rubber of the dust cap (see picture) This ensures a stronger grip.

„Note: Following brake shoe or wheel cylinder replacement ensure all components are correctly positioned. Pay particular attention to wheel cylinder dust cover location.“

Improved parts are:

BWF145A, BWD113A, BWA108A, BWC107A, BWB111A and BWD119A
