# Previous Technical Bulletins

## CL 034 Damaged Drive Plate

Vehicles: All Models

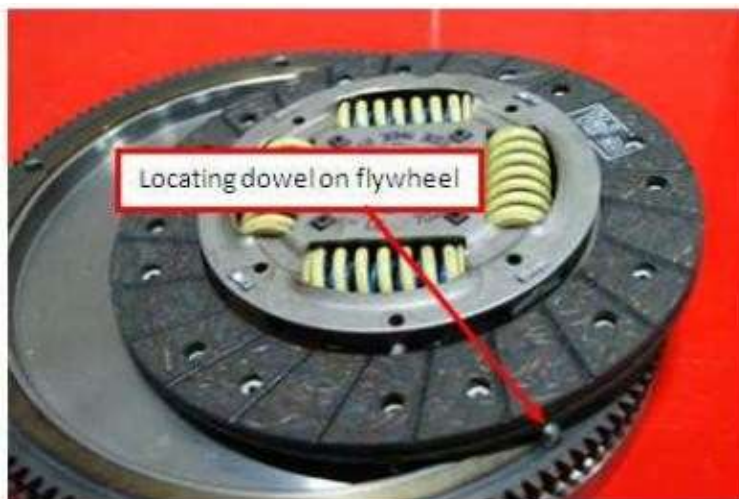
The Valeo Service Warranty Department have received Conversion Kits & DMF Module Kits (clutch & flywheel that are sold together in the same kit), where damage has been inflicted on the clutch plate and it cannot be used. After investigating, the damage caused has been traced to the clutch friction plate coming into contact with the locating dowels on the flywheel.

Image showing how clutch plate becomes damaged from locating dowels on flywheel

Valeo clutch kits sold with flywheels **MUST ALWAYS** be transported and stored horizontally. If the kit is transported vertically, the clutch cover could become detached from the flywheel and allow the drive plate to move between the two parts.
