CL 035 Avoiding Clutch Grease Contamination Vehicles: All Models

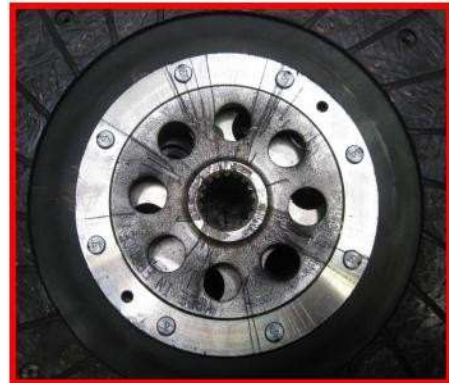
The Valeo Service warranty department receives a number of returned clutches with issues of juddering or slipping of the clutch. After inspecting the returned parts, there is clear evidence of incorrect, too much or incorrectly applied grease which has radiated from the drive plate hub caused by centrifugal force and has coated the friction surface.

Once the grease has come into contact with the friction surface, the coefficient of friction of the drive plate is reduced so it can no longer transmit all of the engine torque resulting in the effect of juddering or slipping.

If this is performed the grease will be pushed out from the splines during fitment to the input shaft and will accumulate on the outside of the hub.

DO NOT APPLY GREASE DIRECTLY TO THE SPLINES ON THE DRIVE PLATE HUB.

Please note it is not necessary to apply grease to the splines if the clutch disc is fitted with a Nickel-coated hub and ensure to never grease clutch discs with "permanently lubricated" hubs. If it is necessary to apply grease during clutch fitment, coat the gearbox input shaft with the correct grease then wipe off the excess grease leaving only a thin film. If too much grease is applied when the input shaft is rotating at engine speed, it will force the grease outwards onto the clutch drive plate and pressure plate causing juddering or slipping.
